**District of Columbia
Fire and Emergency Medical Services Department**

Incident Review Committee

Structure Fire – 809 F Street N.E.

Incident Date – August 2, 2017

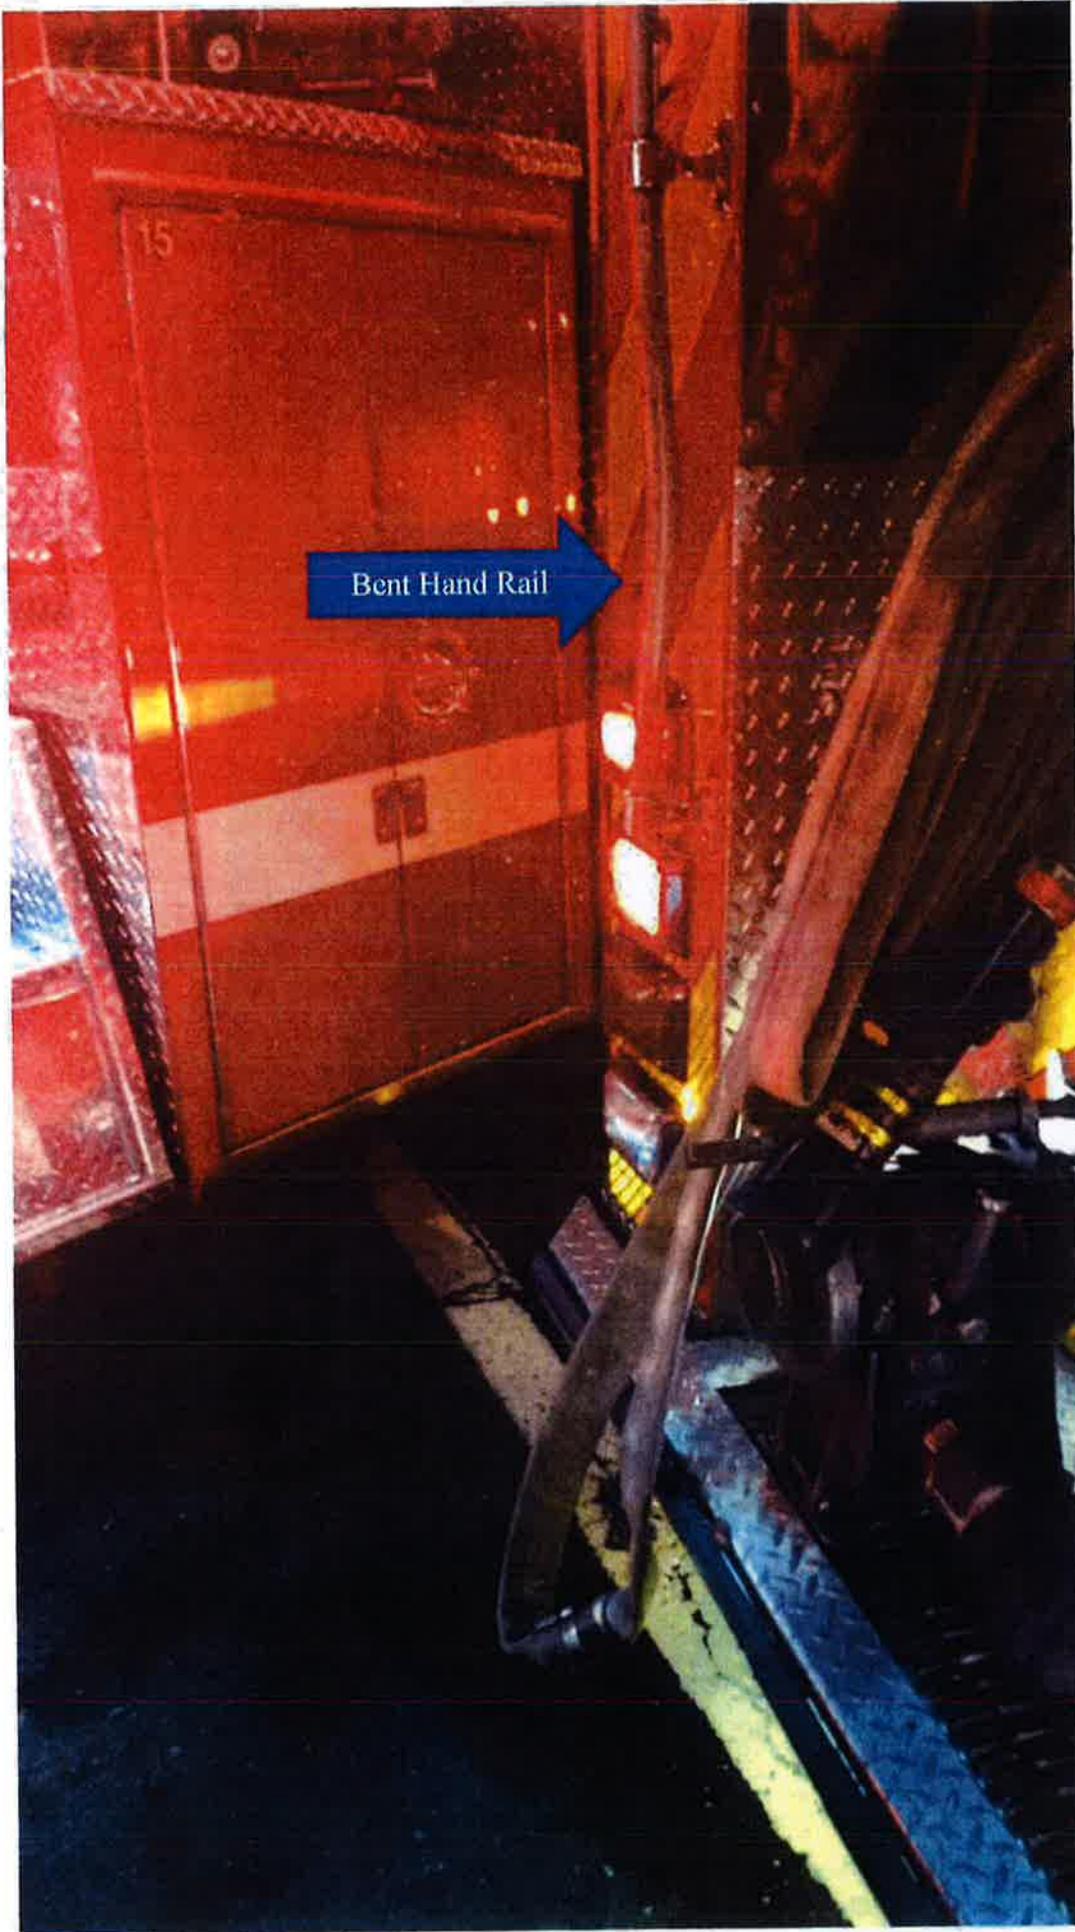
Bent Hand Rail

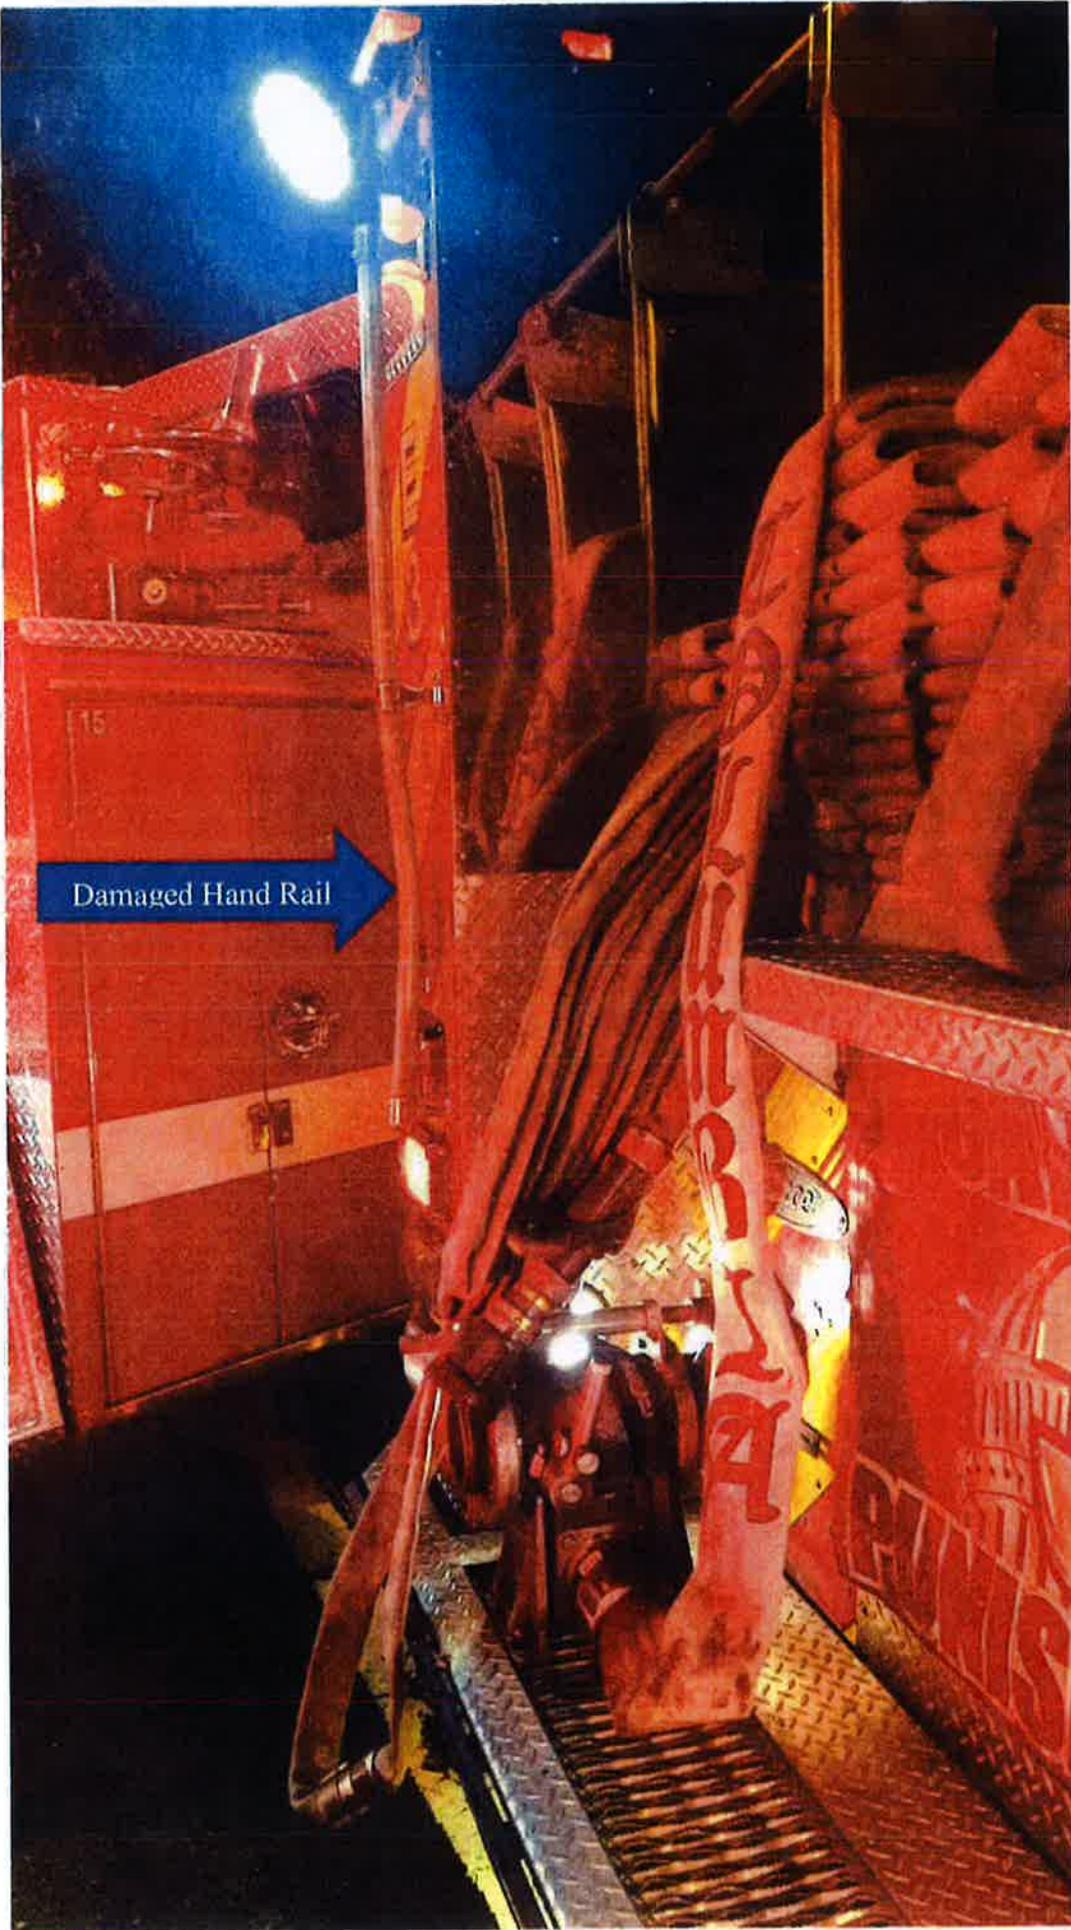
Damaged Hand Rail
