FIREFIGHTER FATALITY INVESTIGATIVE REPORT

**Sofa Super Store
1807 Savannah Highway
Charleston, South Carolina**

**City of Charleston
Post Incident Assessment and Review Team
Phase II Report**

May 15, 2008

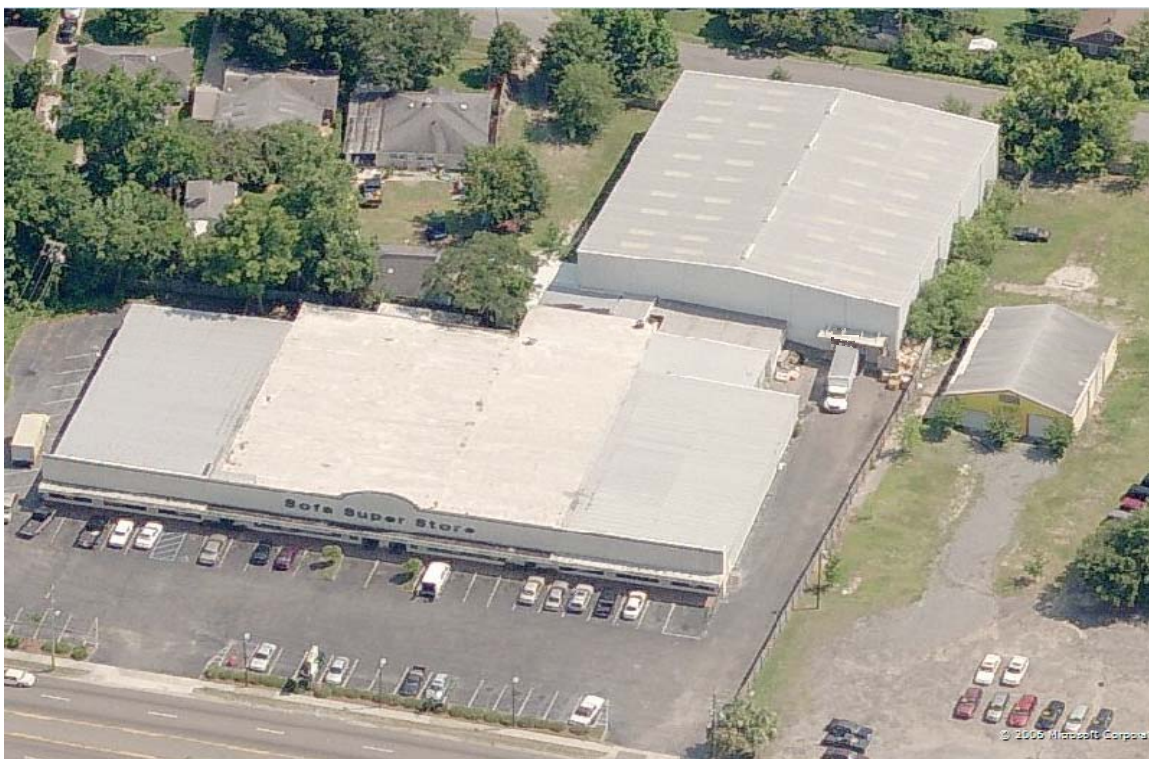
Photo 1: Aerial view of the north side of the Sofa Super Store. (Photo courtesy of Pictometry, International)

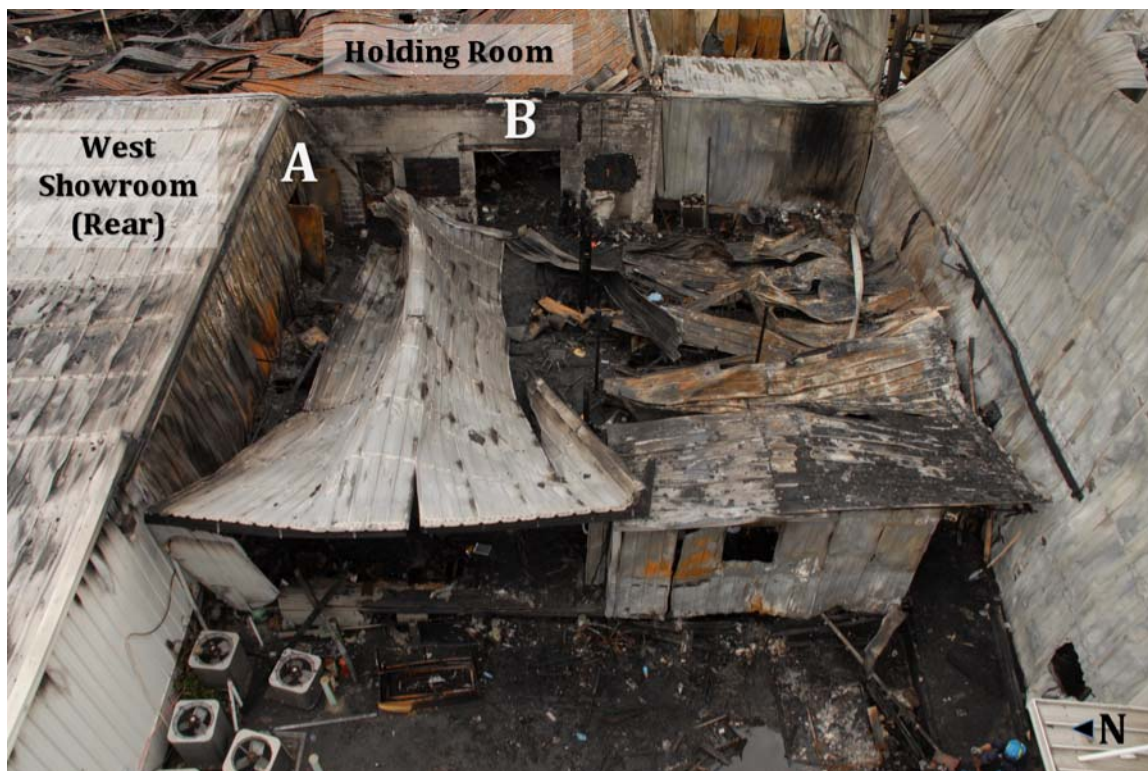
The concrete block wall that separated the loading dock from the rear portion of the original building was compromised by a large open doorway. This opening, which appears to have been a loading dock for the grocery store, was equipped with an electrically operated garage door (non-fire rated). This door was open when the fire occurred. A smaller personnel door also passed through this wall and two window openings had been covered-over in the process of additions and renovations.

Photo 2: Post-fire view of the loading dock. Note the double doors (A) connecting the loading dock to the west showroom at the upper left and the open garage door (B) in the concrete block wall between loading dock and the holding room. (Photo courtesy Bill Murton, Charleston Police Department)

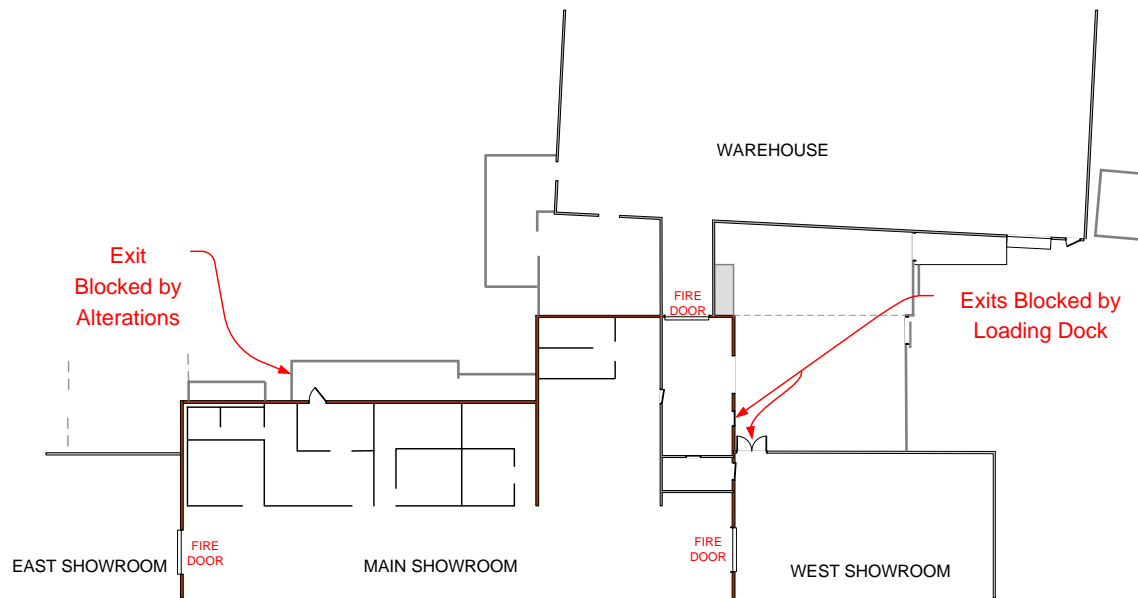
Figure 4: Construction of the loading dock obstructed the egress path from two showroom exits. The construction of offices and modifications to ancillary spaces at the rear of the main showroom obstructed an additional exit.

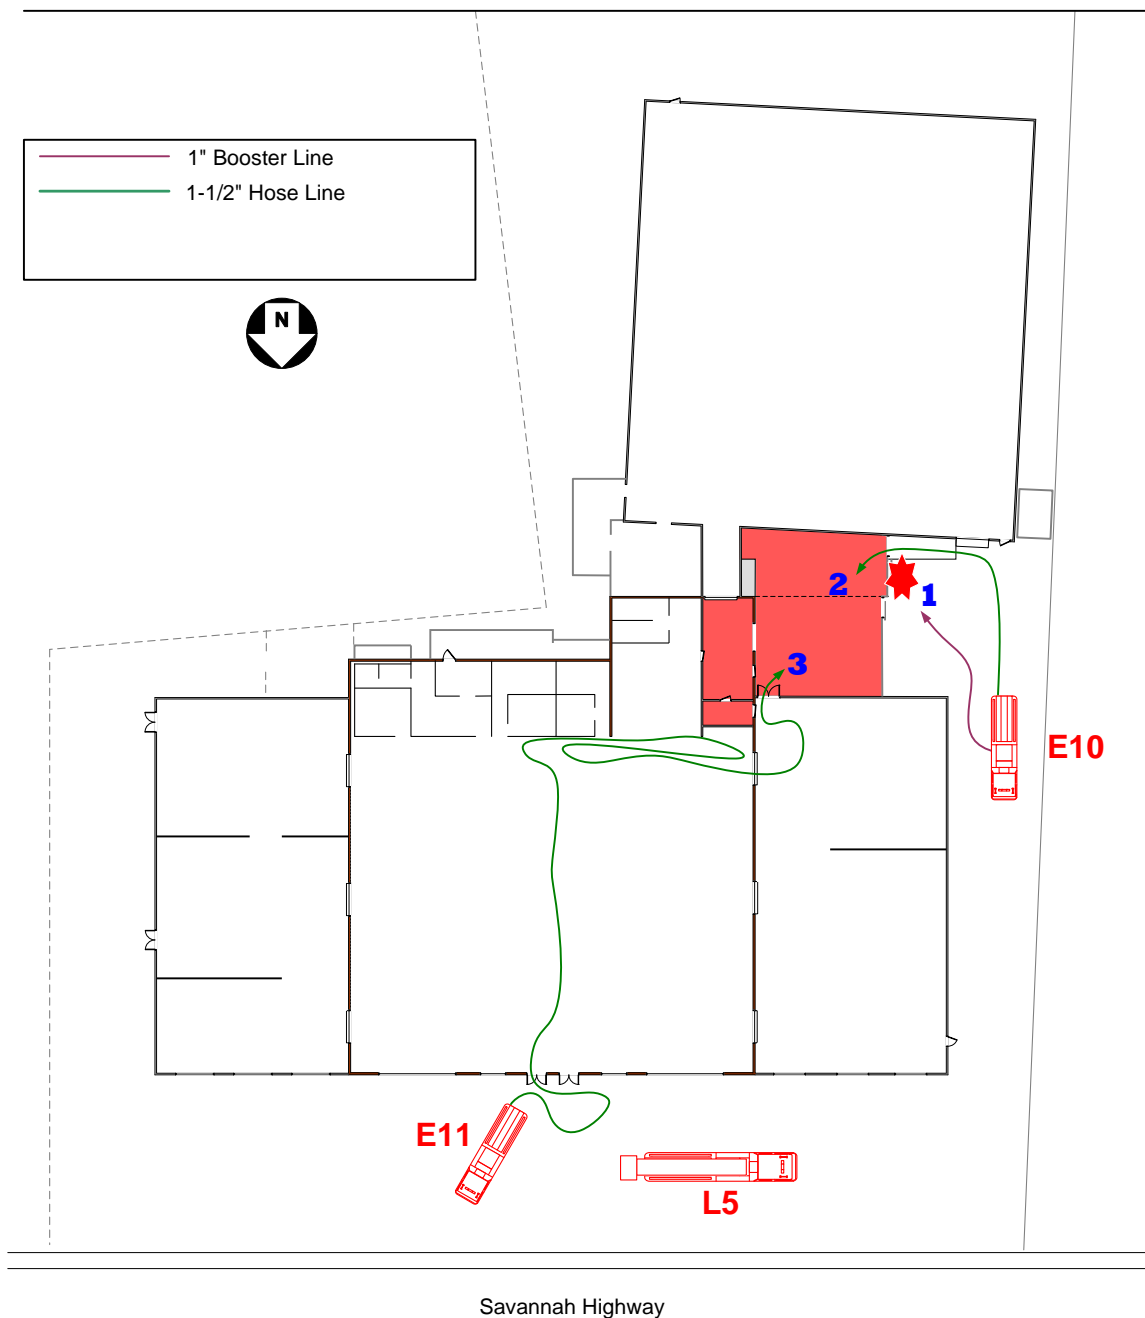
Figure 10: Initial attack hose lines in operation. (Approximate time 19:16)

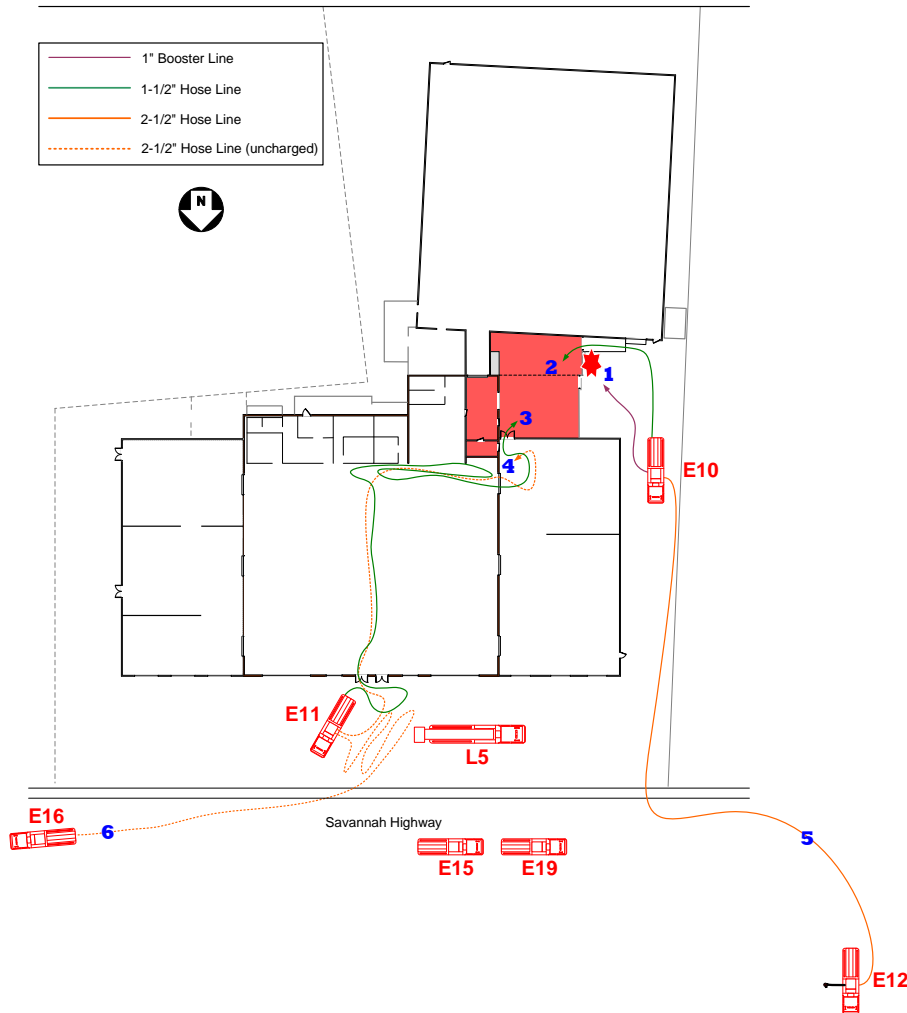
Figure 11: Additional hose lines stretched. (Approximate time 19:20)

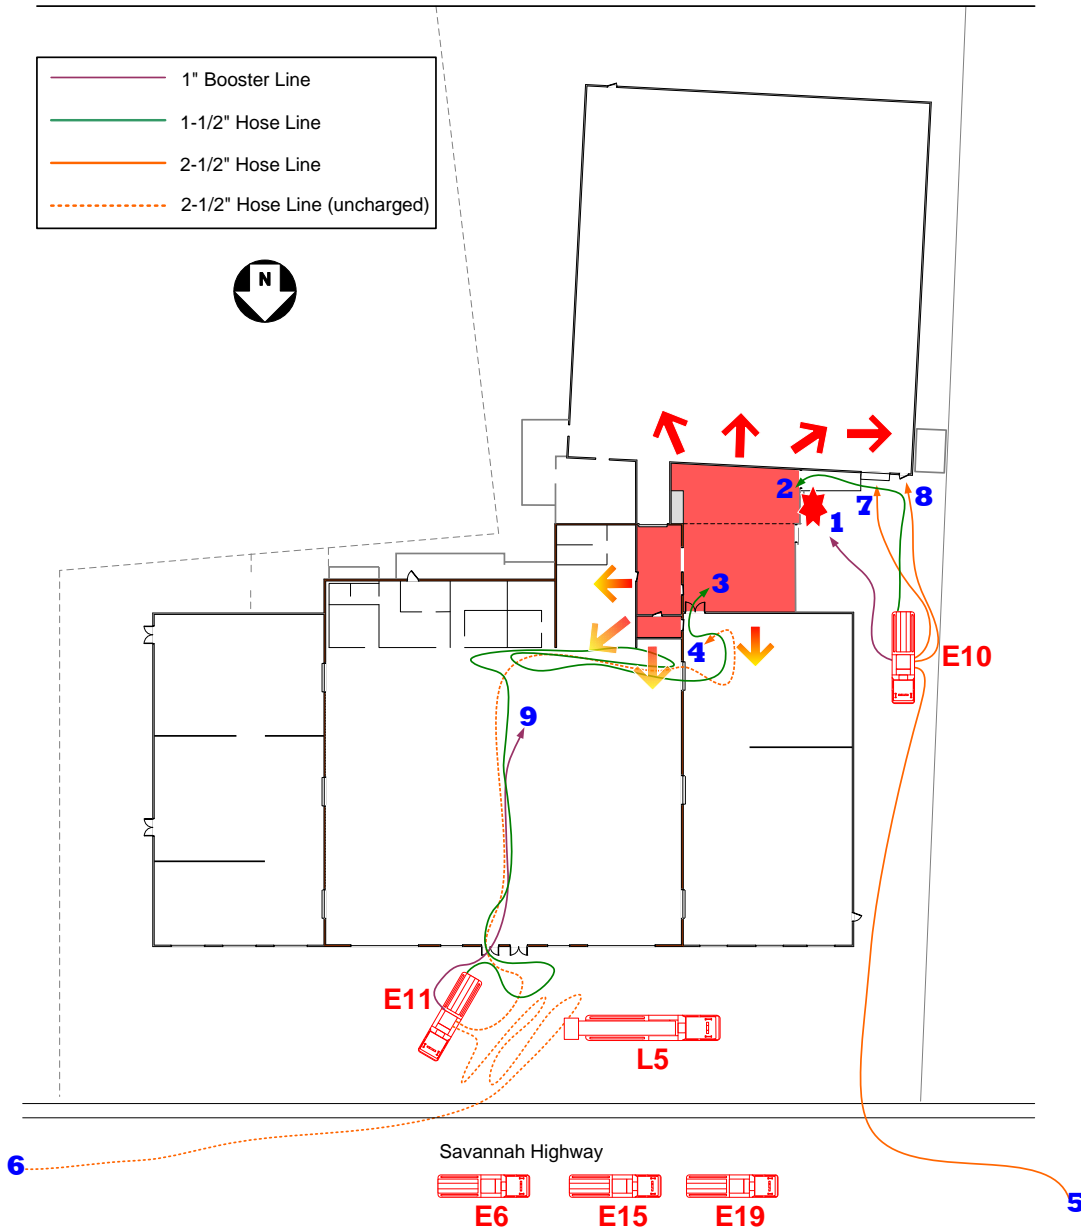
Figure 12: Additional hose lines in operation. (Approx 19:25)

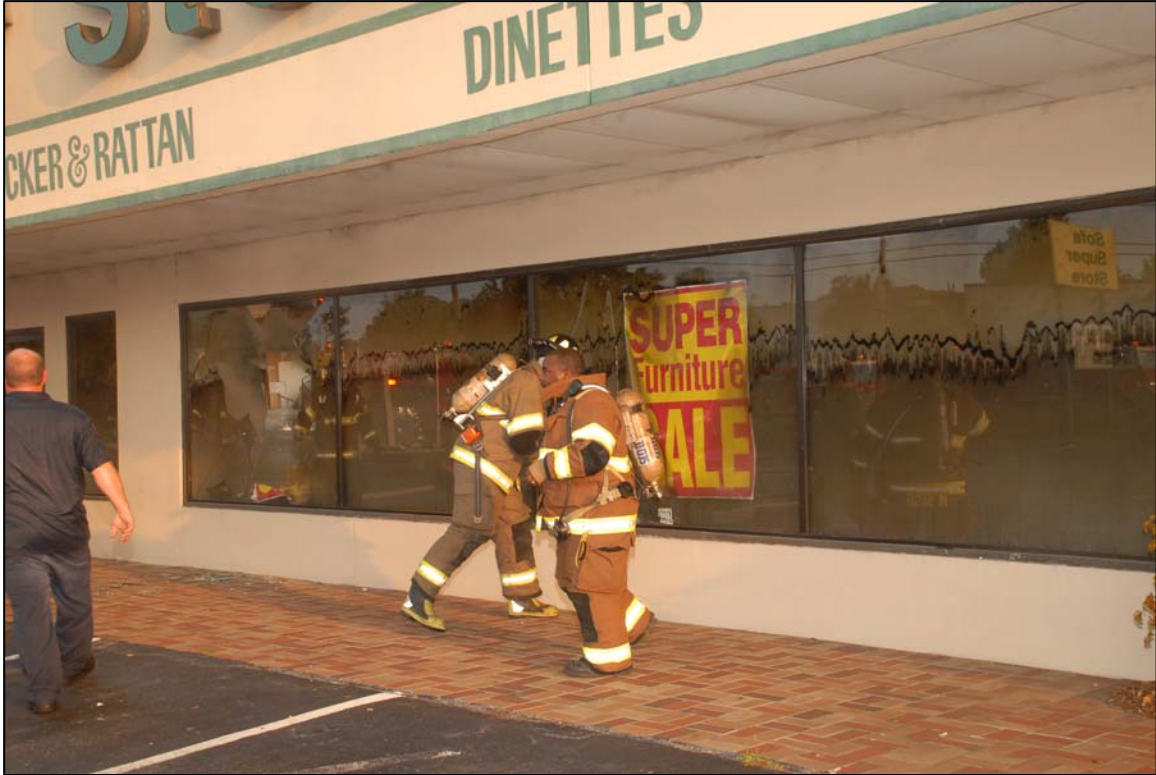
Photo 6: Firefighters break out windows to the right of the store entrance. Note air being drawn into the broken windows to the left of the firefighters. The heat stratification inside the showroom is evident. This photograph was taken at 19:35:31. (Photo courtesy of Bill Murton, Charleston Police Department)

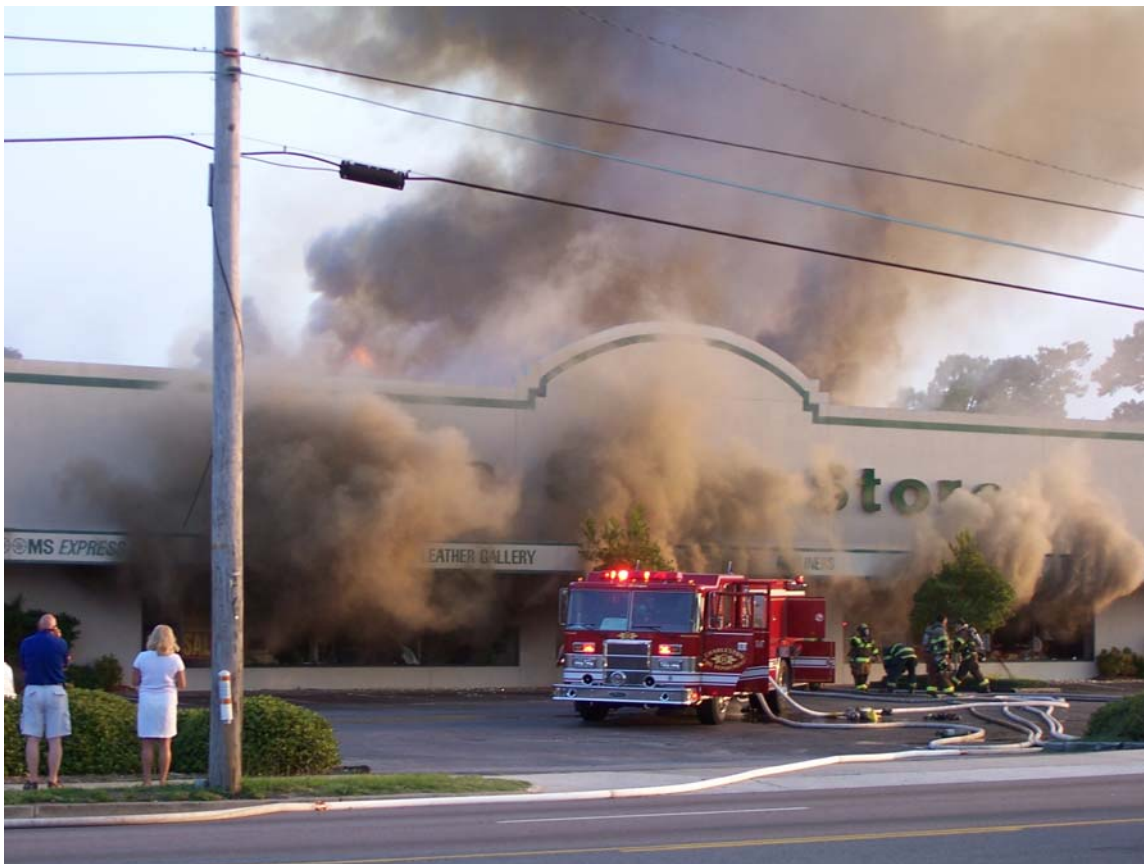
Photo 7: Smoke begins to flow from the broken windows on both sides of the store entrance. This photograph was taken at 19:36:05. (Photo courtesy of Stewart English)

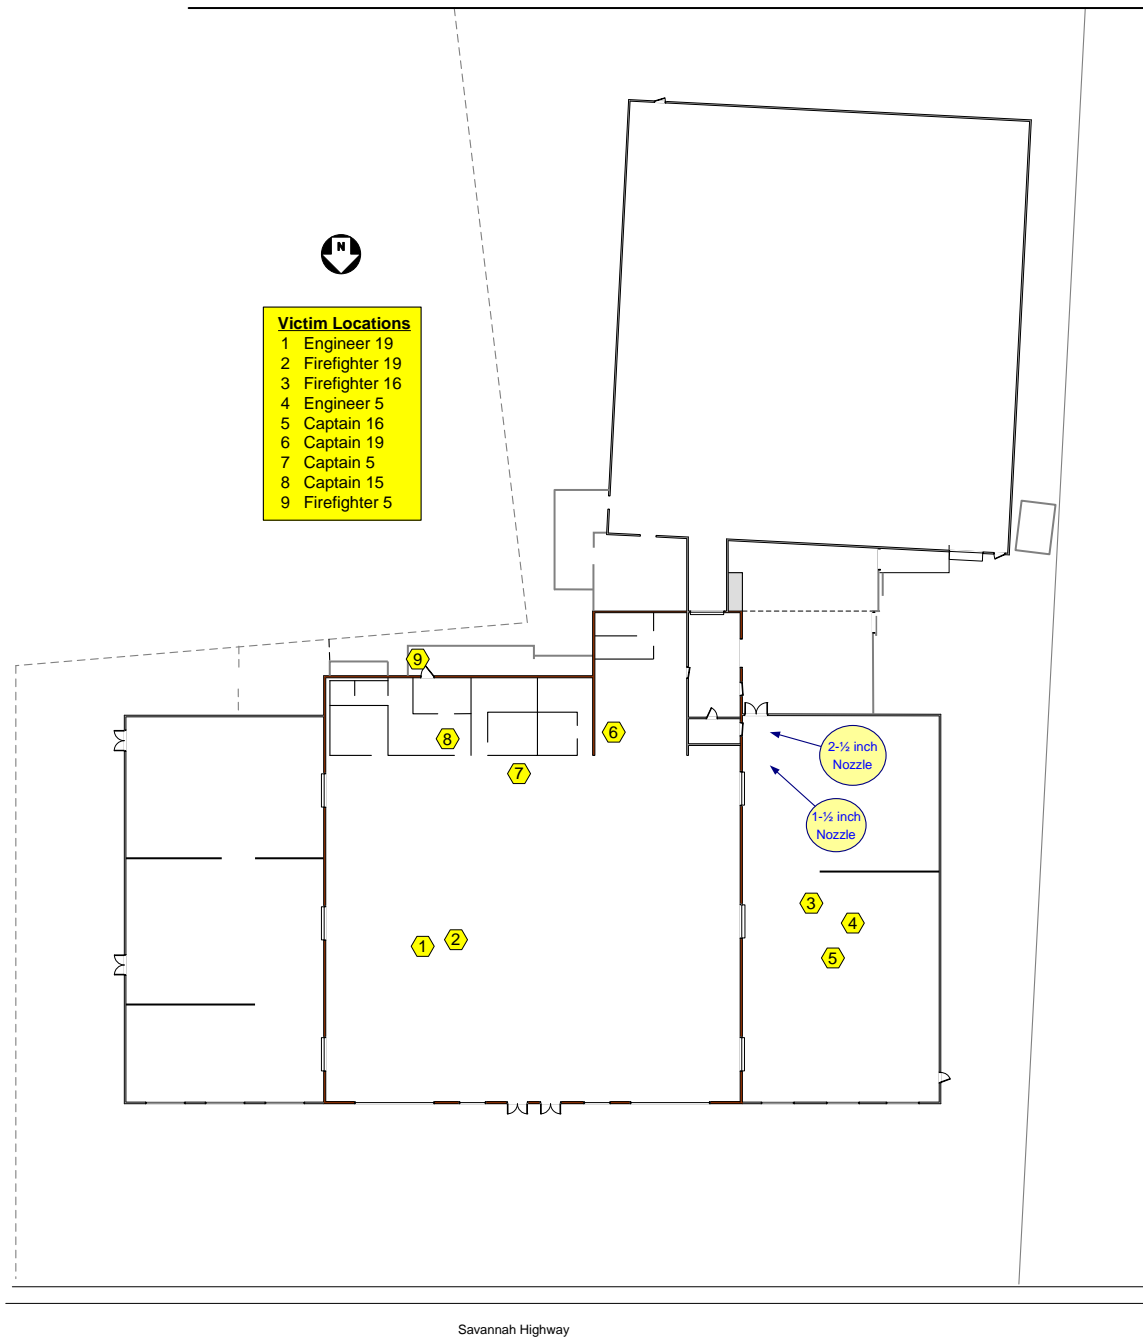
The evidence indicates that the structural collapse of the roof occurred after the firefighters were incapacitated or deceased. The roof of the main showroom did not collapse until almost 20 minutes after the interior became fully involved in fire. The roof collapse did not cause their deaths.

Figure 15: Locations of the deceased firefighters as recorded by the Charleston County Coroner.

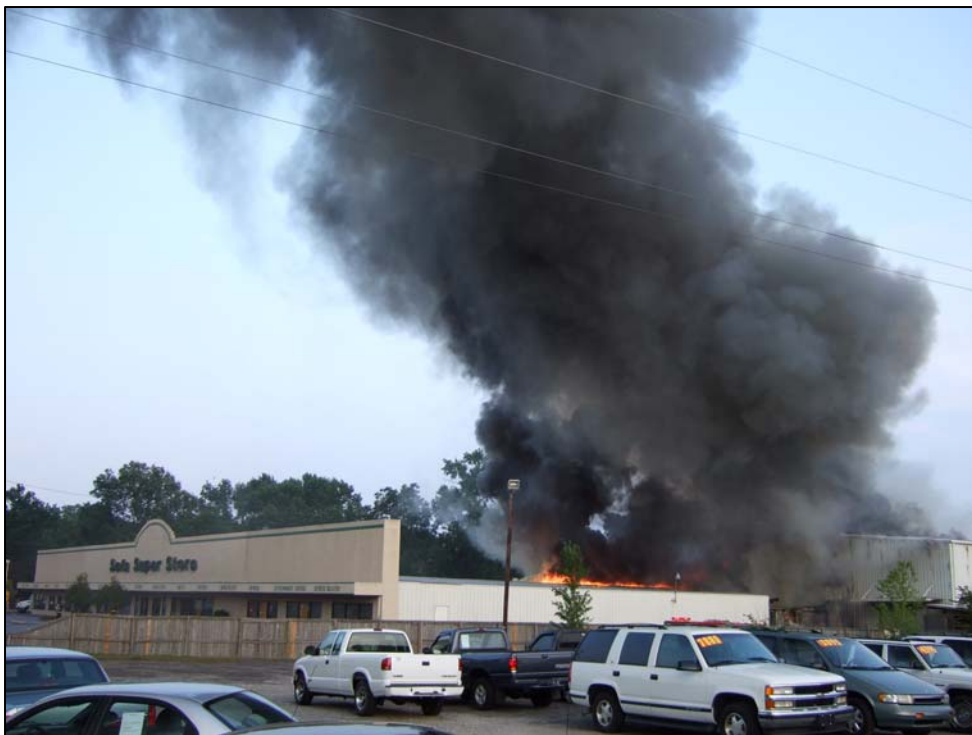
A series of photographs taken on the west side of the building begins at approximately 19:23 hours²². These photographs show heavy smoke and flames at the roof level, above the west showroom, extending toward the front of the building. Subsequent photos and videos show smoke issuing from below the roof along the west side of the building. The photos establish that the fire had extended into the void space above the west showroom at that time; however, there is no evidence to make a determination if there was fire in this space earlier than 19:23.

Photo 9: Fire visible from the roof of the retail area. This photo was taken at 19:23:16. (Photo courtesy of Dan Folk)

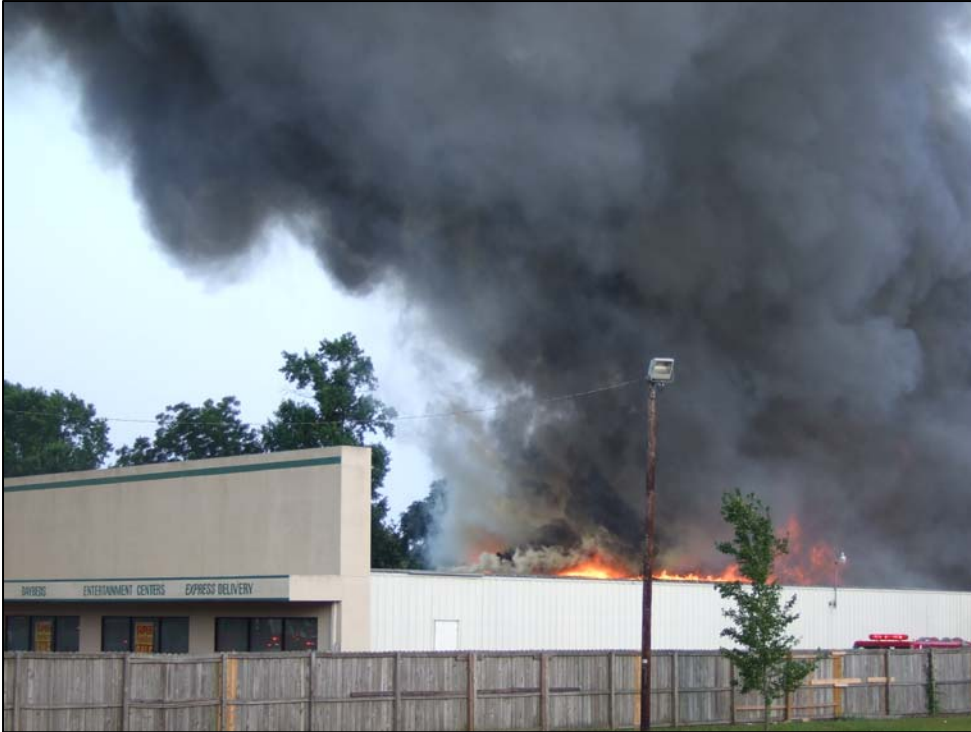
Photo 10: Fire visible from the roof of the retail area. This photo was taken at 19:23:46. (Photo courtesy of Dan Folk)
