A summary of a NIOSH fire fighter fatality investigation

Nine Career Fire Fighters Die in Rapid Fire Progression at Commercial Furniture Showroom – South Carolina

Fatality Assessment and Control Evaluation Investigation Report # F2007-18

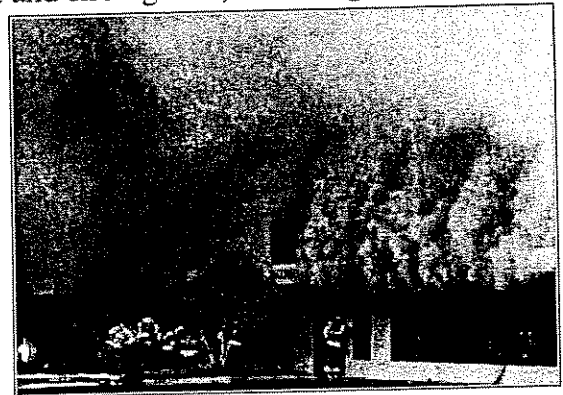
Incident Scene: Photo courtesy of Alexander Fox, Associated Press.

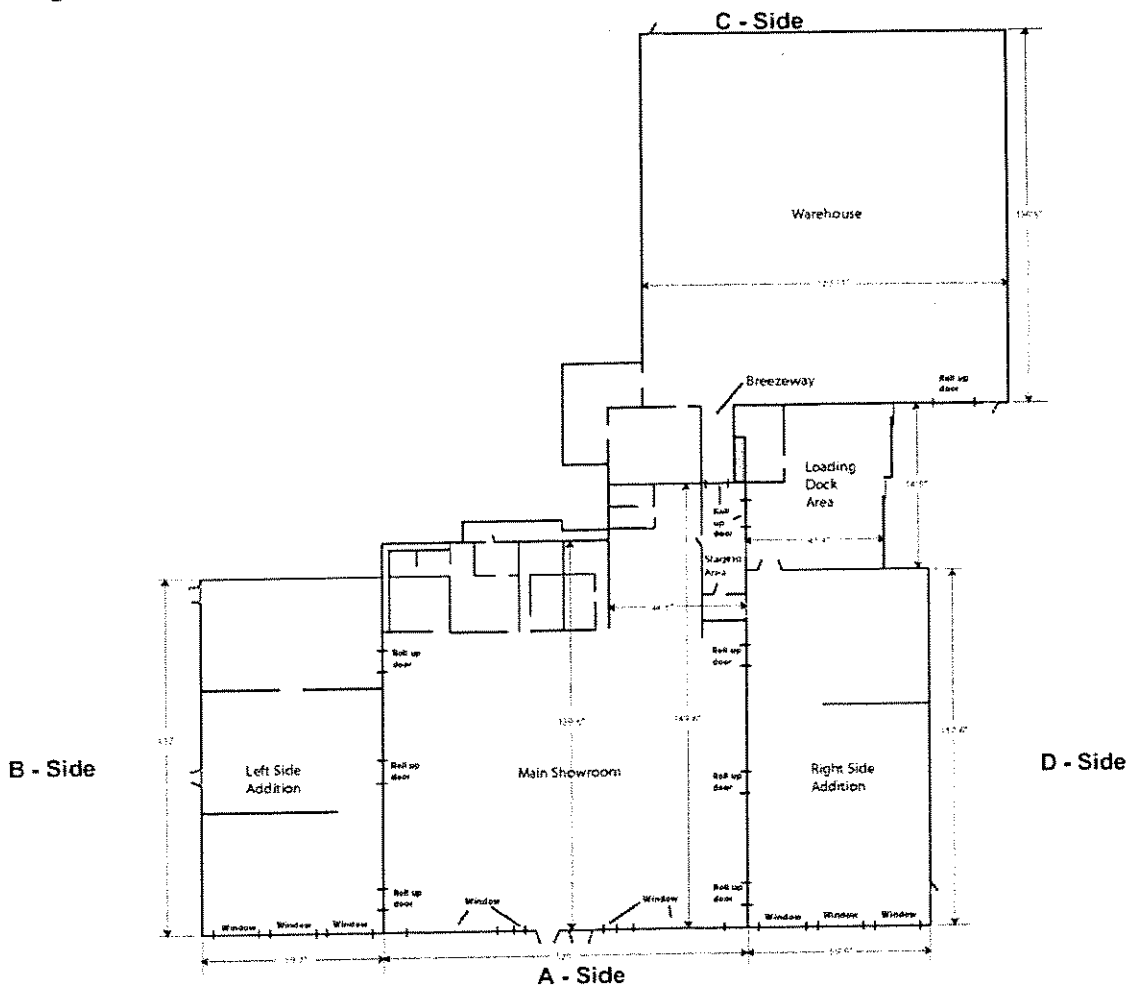
Diagram 1: Courtesy of NIST

The E-16 engineer was instructed to lay a supply line for E-11 so he drove back onto the highway heading north, then turned down a side street to where a hydrant had been previously located. This hydrant had been removed in 2004 because it had received damage from heavy truck traffic in the immediate area. He had to back out onto the highway and continue north to the next hydrant located approximately 1,200 feet away. *Note: It was reported that 23 50-foot sections of 2 ½" supply hose were stretched from E-11 to the hydrant.* The E-16 engineer reported hearing the radio traffic about the civilian worker being trapped in the rear of the building just as he was pulling up to the hydrant. (see Diagram # 1)

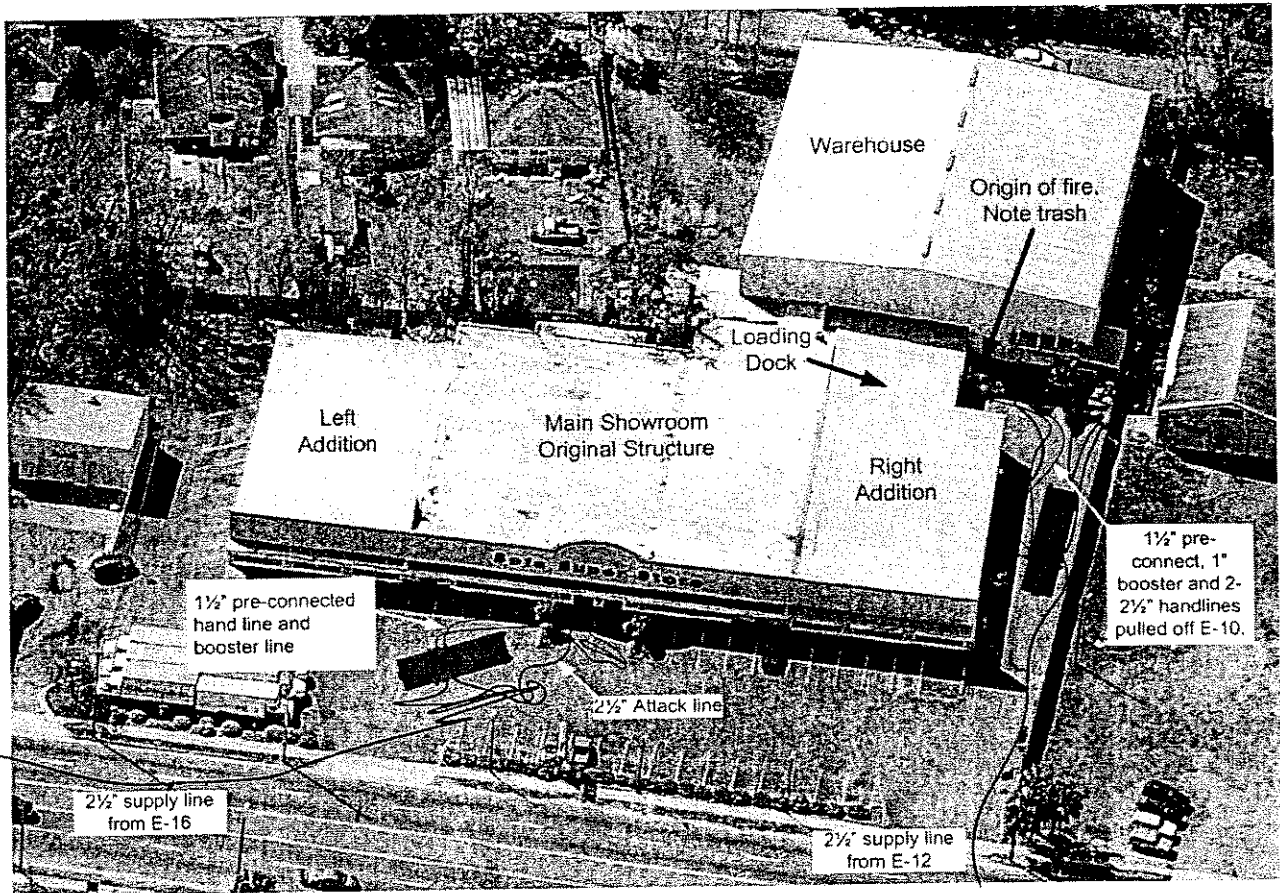
Diagram 2 – From aerial photo taken in 2006 (source – NIST). Note accumulation of trash at loading dock on the day photo was taken. Note the absence of ventilation ductworks or other roof penetrations over the showroom, thus no path or smoke and hot gases to escape.

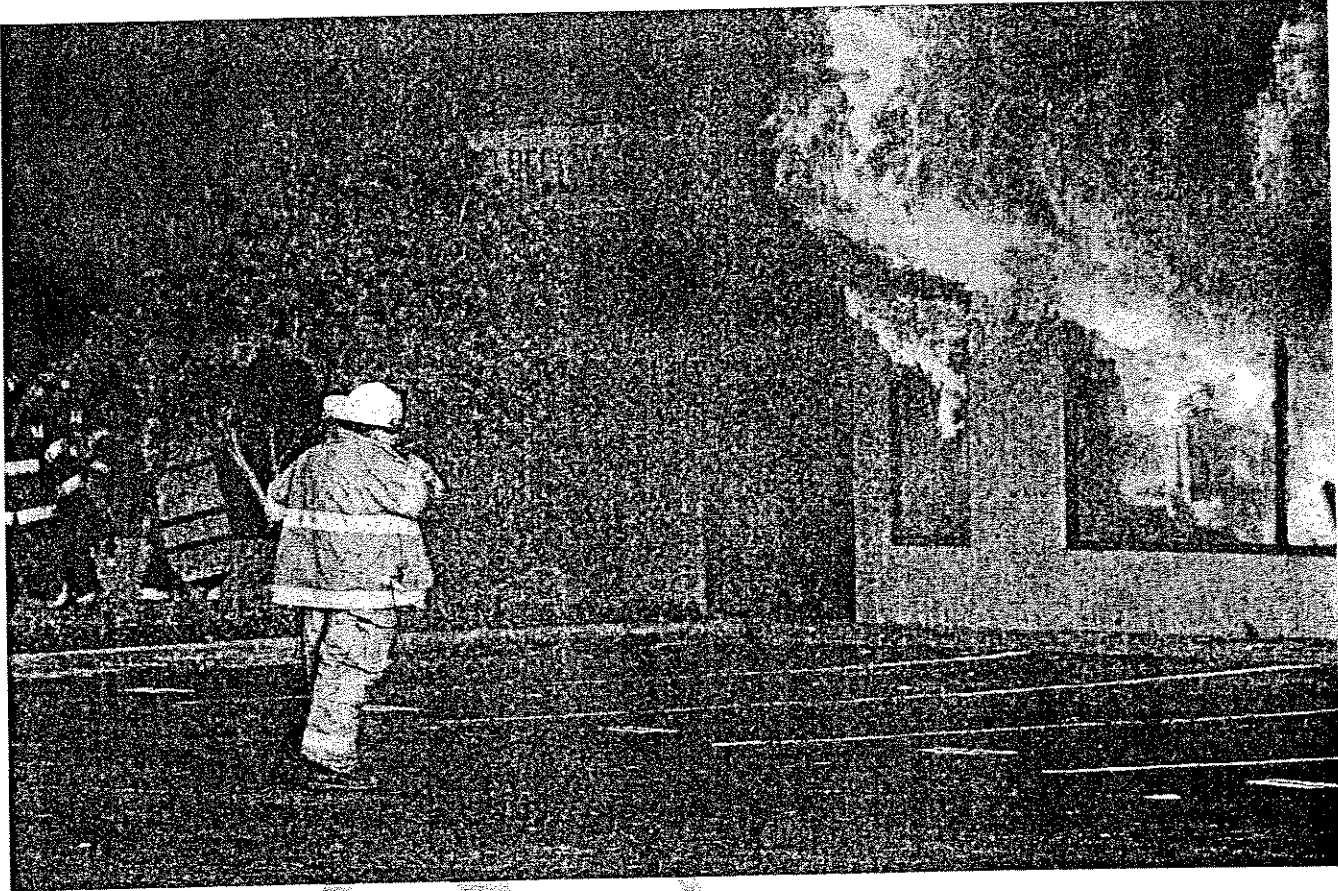
Photo 2: Time approximately 1938 hours. Photo shows conditions at front of showroom just before the interior search and rescue attempts were halted due to the interior conditions. Photo courtesy of Bates.

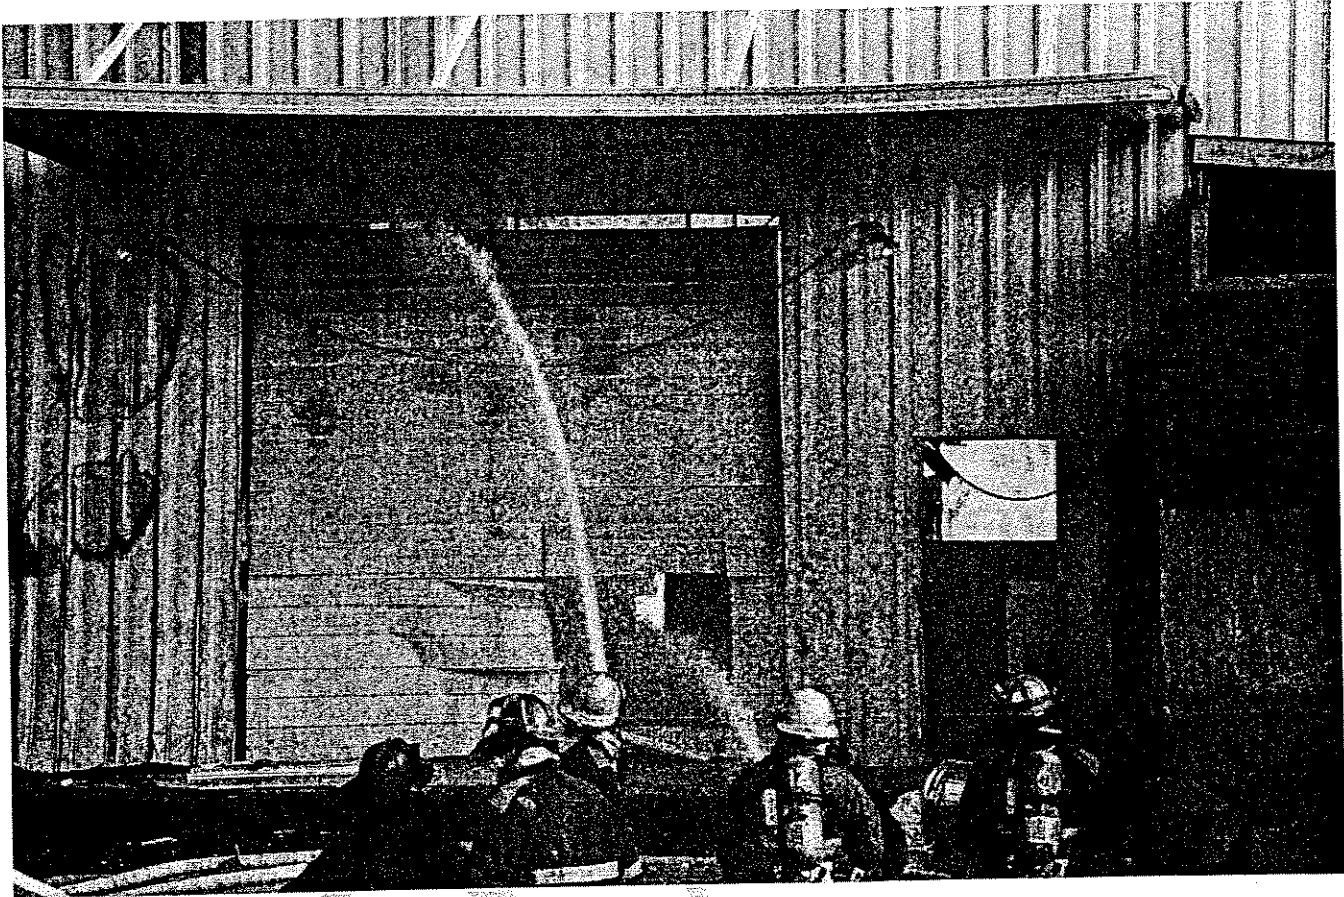
When the E-10 attack crew exited the loading dock, they asked fire fighters from Engine 12 (E-12), just arriving on-scene, to repair the damaged 1 ½" hand line. The E-10 captain and fire fighter got the 1" booster line that they had previously pulled off E-10 and advanced the booster line into the loading dock. *Note: While getting ready to advance the booster line, the E-10 captain heard radio traffic about a civilian being trapped at the rear of the structure.* The booster line did not have any effect on the fire so they backed the line out, switched back to the 1 ½" hand line and moved back into the loading dock a third time. The Chief came to the loading dock and yelled inside to tell the E-10 captain not to advance any further. A few seconds later, the Chief ordered the E-10 crew outside. (See Diagram # 2) *Note: The E-10 crew was inside the loading dock approximately 15 minutes total.* BC-4 returned to the front of the building and asked the manager if he had keys for the warehouse at the rear of the loading dock. The manager said no so BC-4 returned to the loading dock and directed the E-12 crew and off-duty fire fighters who had responded to the scene to cut through the warehouse's roll-up door with a power saw. The crews experienced trouble with getting the saw to run properly so axes were also used to cut holes in the warehouse walls. BC-4 also directed the E-10 crew to assist with opening up the warehouse. BC-4 then directed the E-10 crew to get a 2 ½" hand line with stack-tipped nozzle from E-10 and pull it to the warehouse door. By this time, the warehouse was fully involved (See Picture 3)

Photo 3: Time approximately 1942 hours. Engine 10 and Engine 12 crews battle fire in warehouse from outside. Photo courtesy of police department.

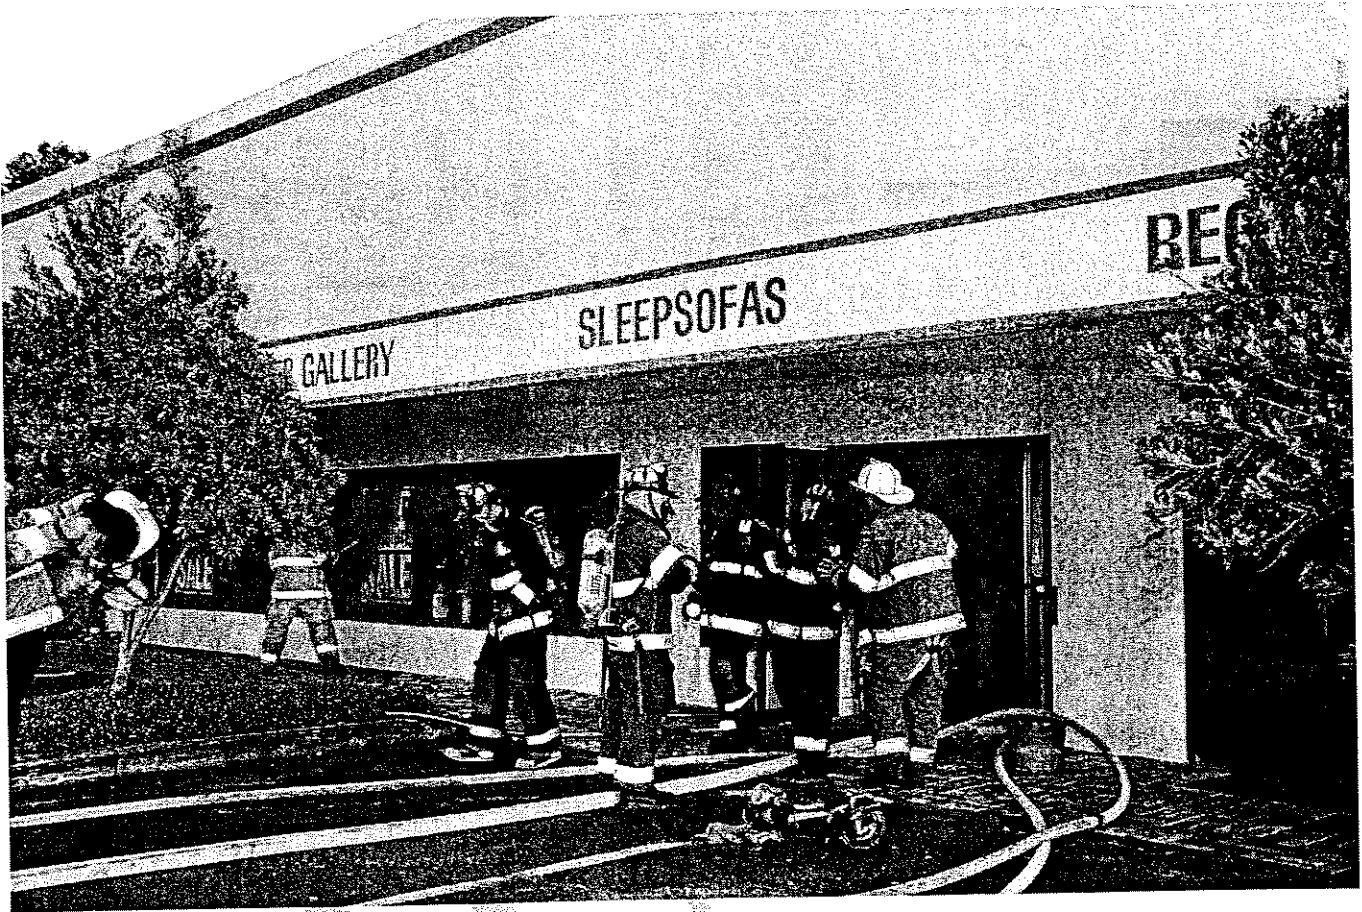
As the heat rapidly intensified, the E-6 captain began following the hoseline outside. His low air alarm started to sound and he burned his hands feeling for the hose line. His facepiece began to pull down onto his face as he exhausted his remaining air supply. He encountered the E-6 fire fighter who told the E-6 captain he had the hose line and they began moving toward the front of the building. By this time, the E-6 captain was almost completely out of air and he bolted toward the front of the building. The E-6 engineer was following the hoseline back into the showroom looking for his crew and encountered the E-6 captain who was desperately low on air and becoming disoriented. The engineer grabbed his captain and guided him toward the front door until they could hear the sound of Engine 11 running outside. They made their way outside followed seconds later by the E-6 fire fighter and the E-15 fire fighter # 1. The front showroom windows were just being knocked out when the E-6 crew exited the showroom (See Photo 4).

Photo 4: Last surviving crews exit showroom at approximately 1935 hours. Photo courtesy of police department.

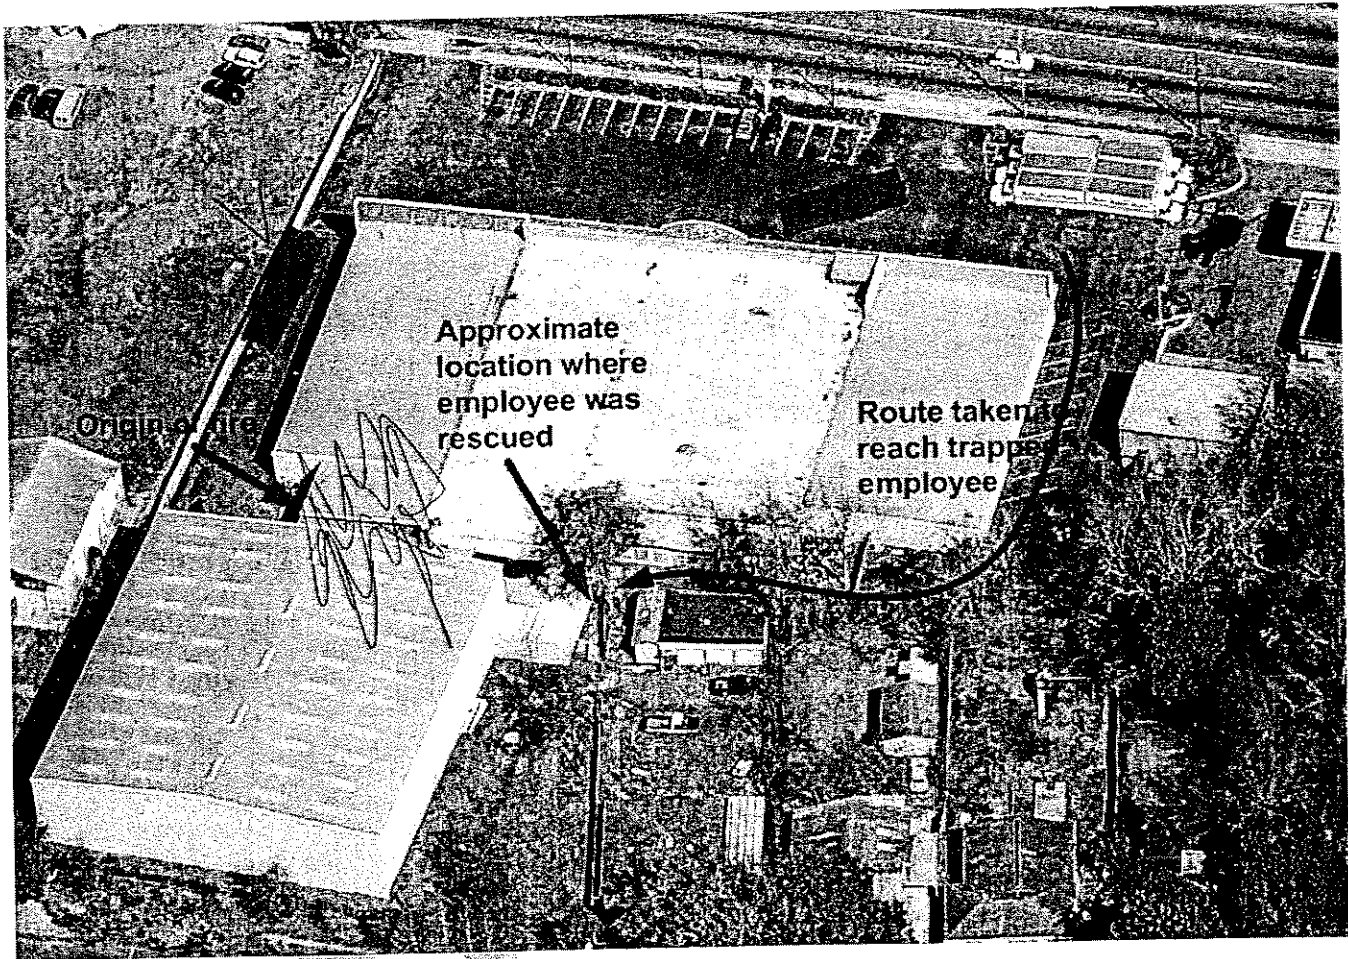
Diagram 3: From aerial photo taken in 2006 (source – NIST). Location where mutual aid crew cut through exterior wall to extricate male employee trapped inside the warehouse.

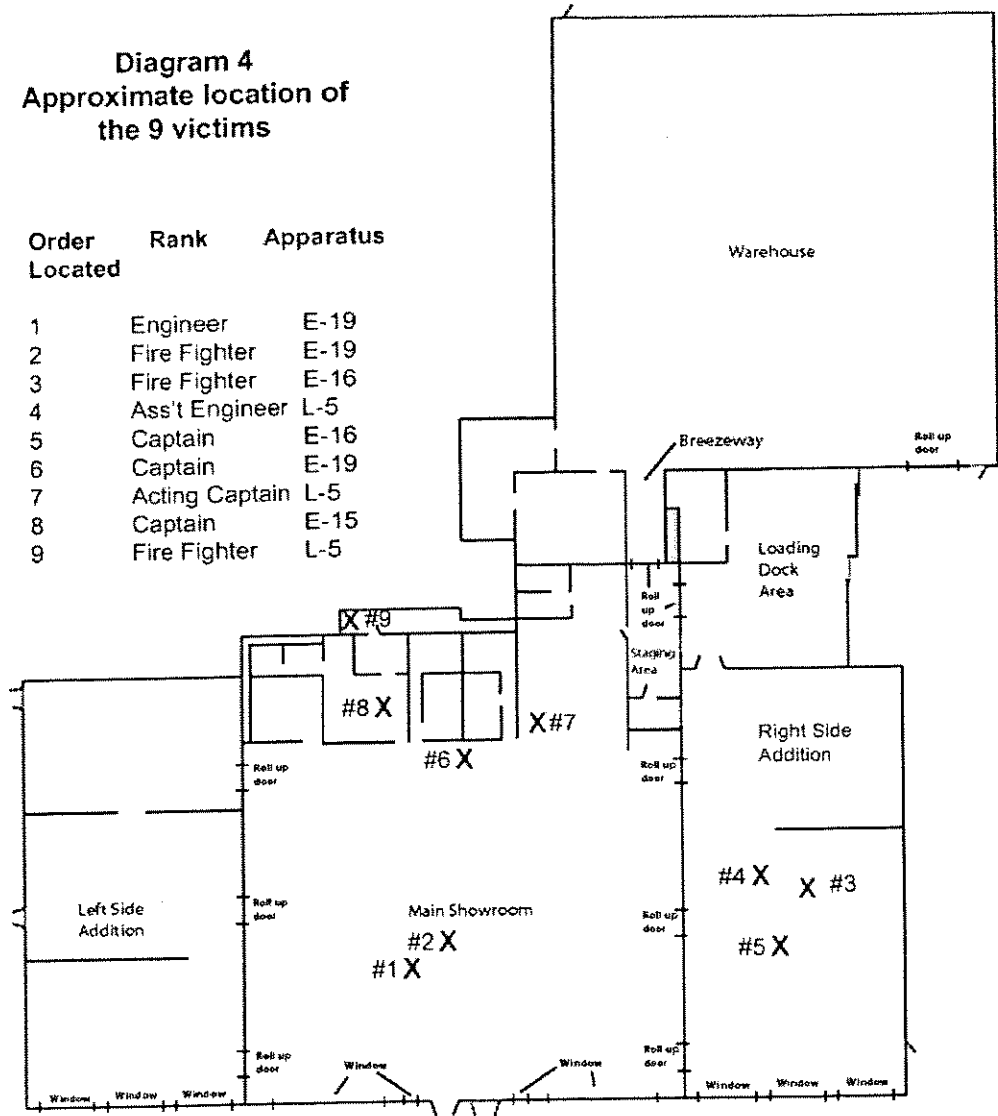
Diagram 4
 Approximate location of
 the 9 victims

According to the County Coroner's report, the cause of death for all nine victims was carbon monoxide toxicity, smoke inhalation and thermal injury due to fire. Diagram 4 shows the approximate location where each of the nine victims was located inside the structure.

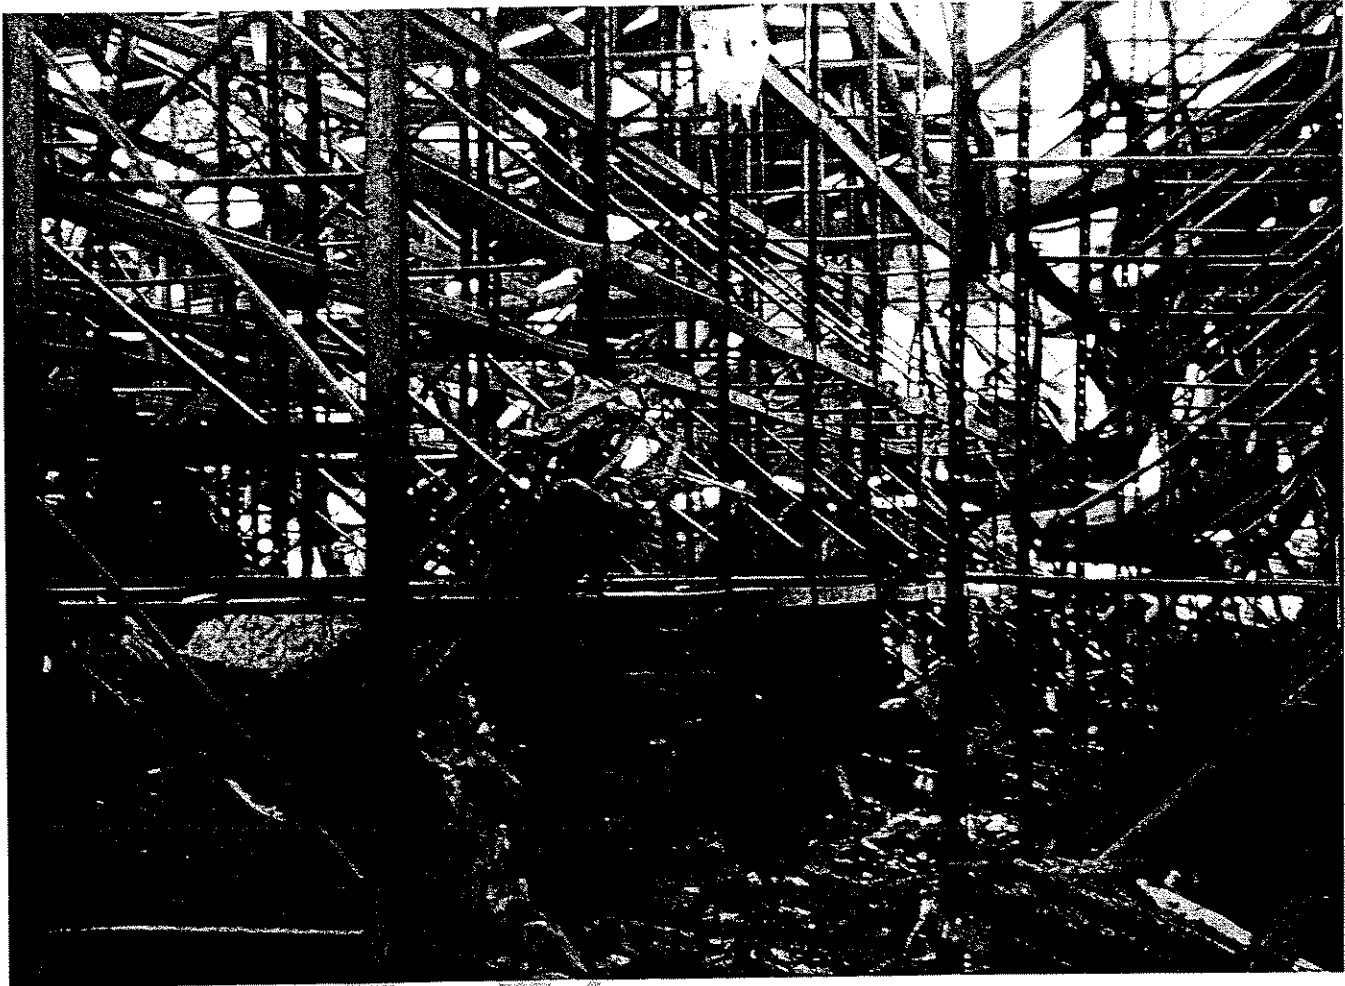
Photo 5: Storage racks in warehouse post fire. Storage racks were filled with various furniture and mattress items. Note the extent to which the storage racks filled the warehouse which gives an indication of the volume of merchandise and the fuel load inside the 15,600 square foot warehouse. The warehouse measured approximately 130 ft. by 120 ft. and was 29 ft from floor to roof. Photo – NIOSH.

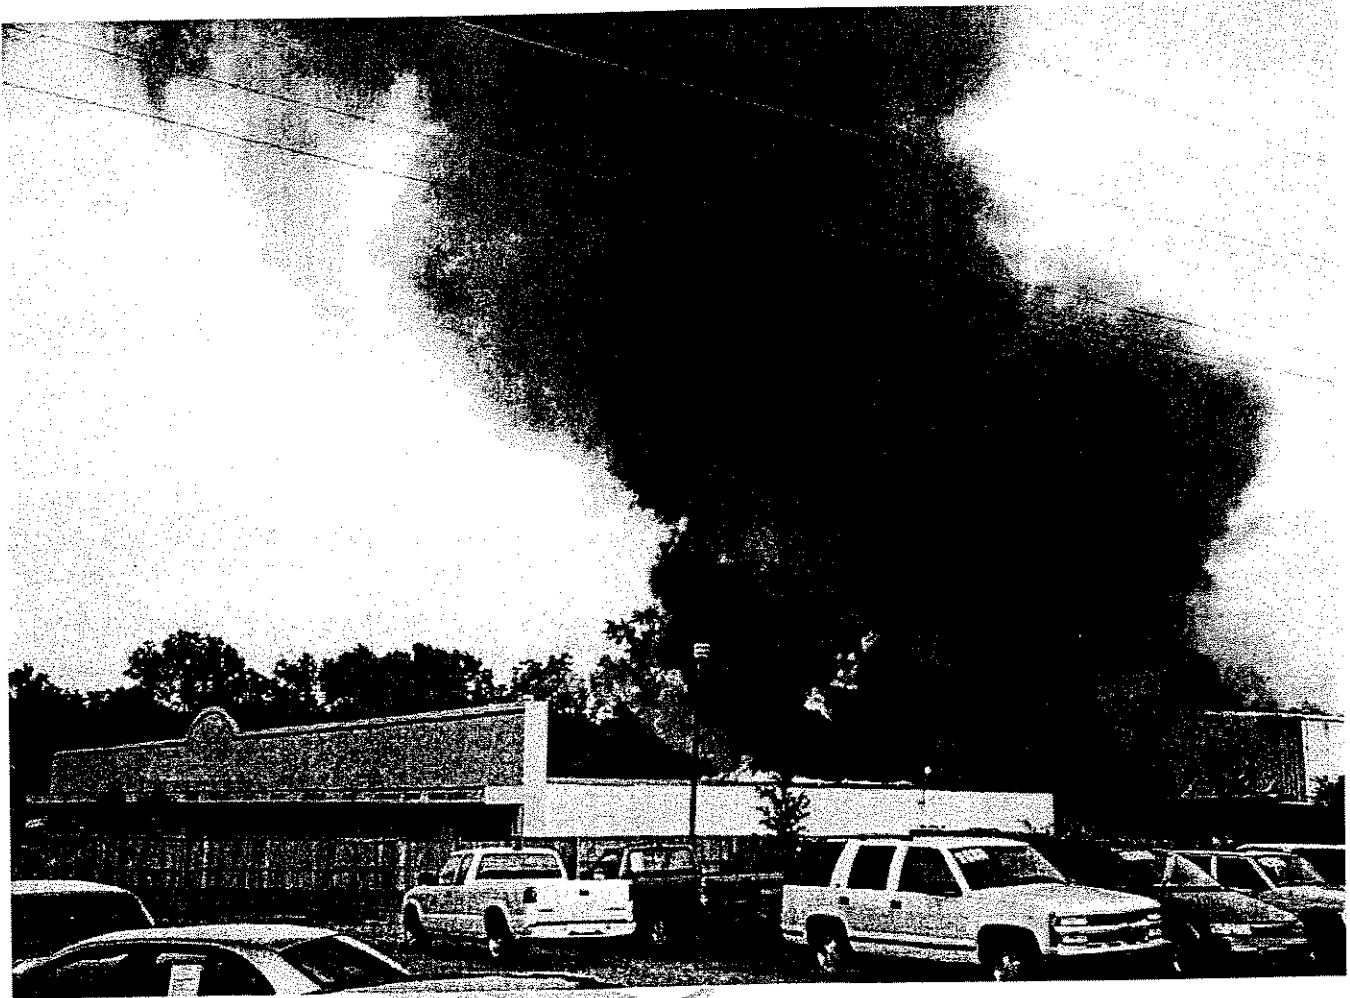
Photo 6: Time is approximately 1923 hours. Fire is visible over showroom roof. Smoke is dark gray in color and becoming turbulent. The flames may not have been visible from front parking lot or close to the building on the D-side. Photo courtesy of Folk,

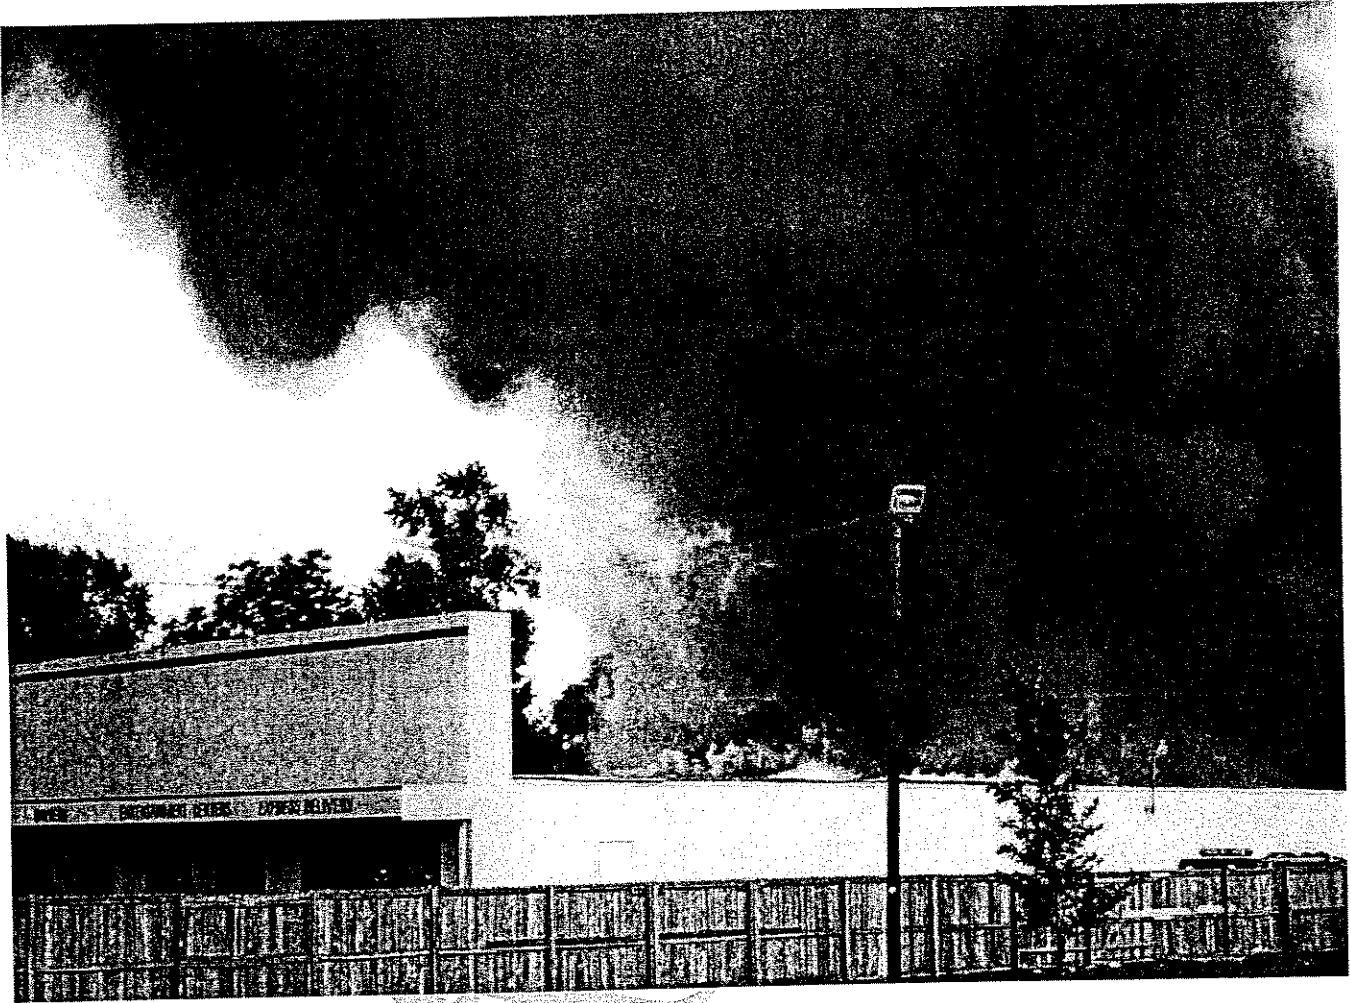
Photo 7: Time Approximately 1924 hours. Fire continues to grow above the loading dock and showroom roof. Photo courtesy of Folk.

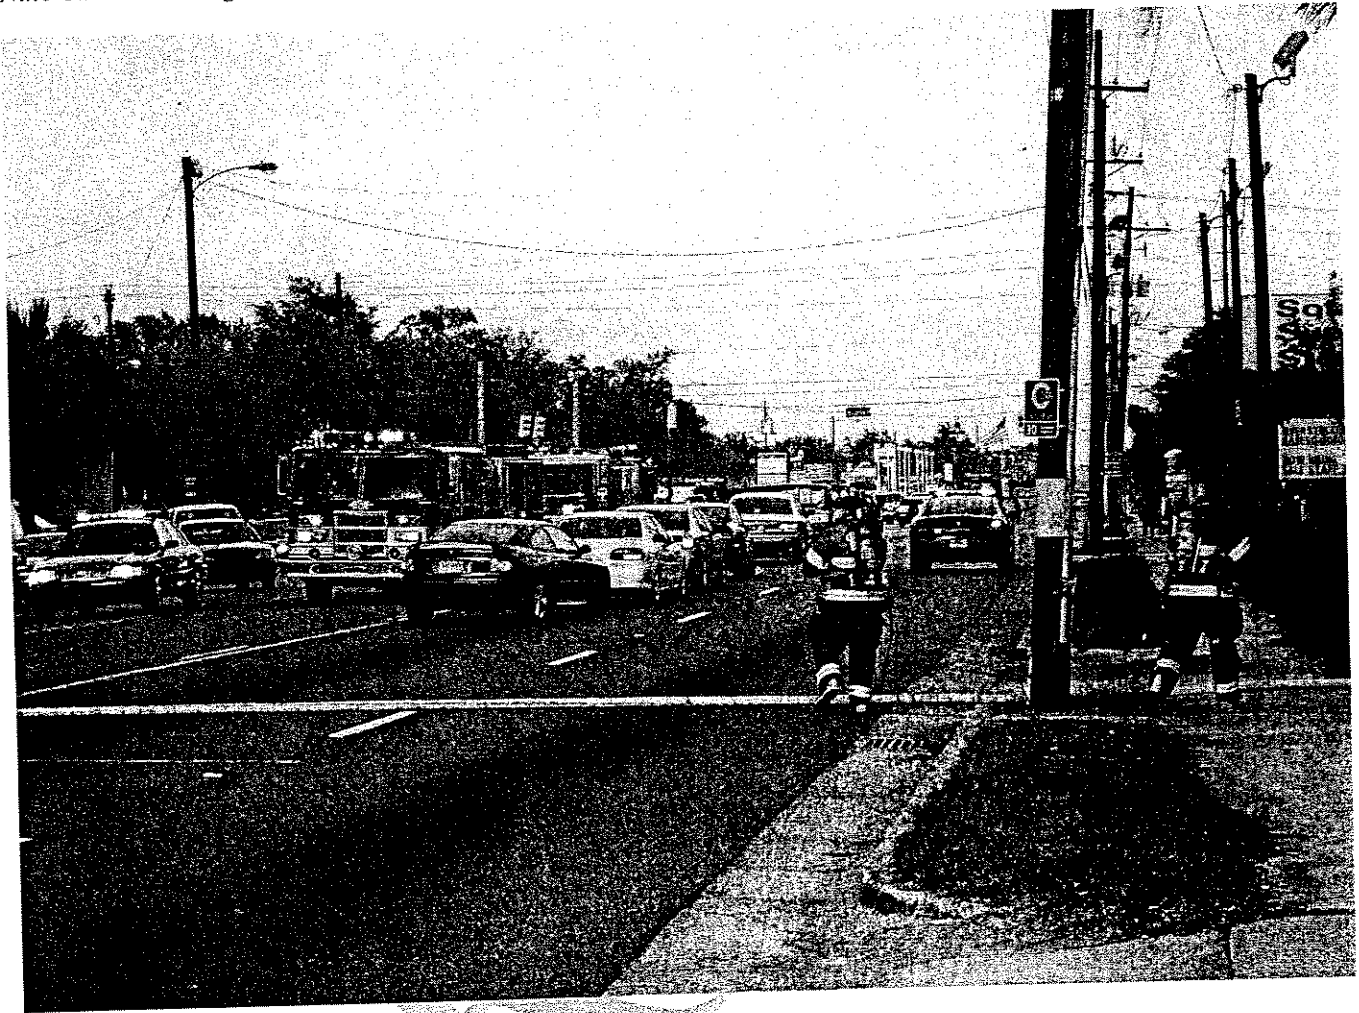
Photo 8: Time Approximately 1925 hours. Note traffic on major highway in front of incident site driving over 2 ½ inch supply line. Hose line runs from Engine 12 (to left of photo) to Engine 10 (to right of photo). Photo shows mutual aid crew members arriving on scene. Photo courtesy of Folk.

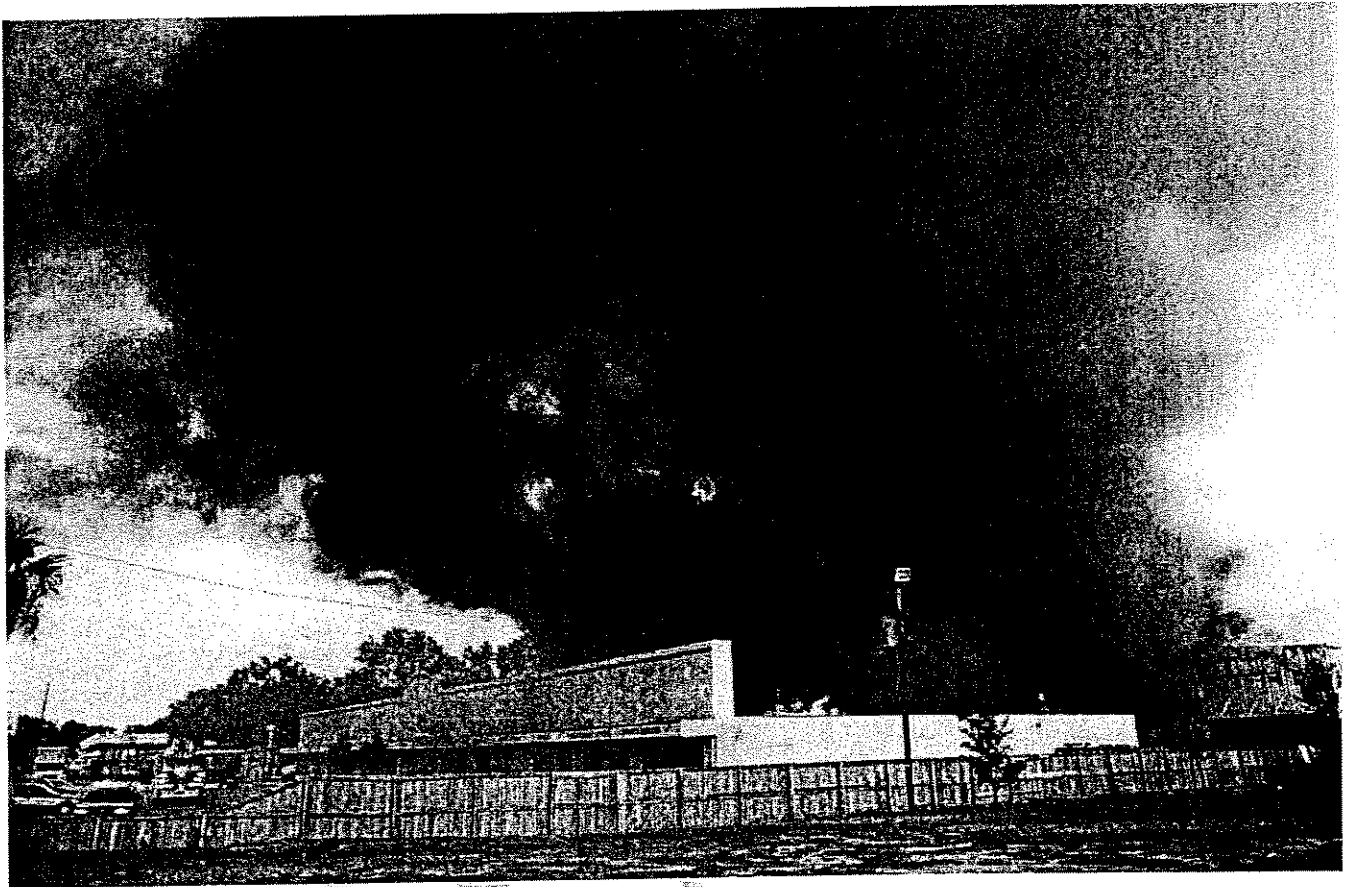
- **1931 hours – 1934 hours (reference photo #9 and #10)**
More broken radio traffic from fire fighters in distress
Chief asks for E-3 to come to scene and lay supply line to L-5
BC-5 reports civilian is out of building
E-16 engineer radios dispatch that police department is needed to prevent traffic from running over supply line.
FF calls Mayday; another FF heard praying; another FF says “I love you”
Chief asks AC “is everyone out?” AC responds the civilian is out

Photo 9: (193011 Fox). Time approximately 1930 hours. Note how smoke has changed to dark black color indicating it is rich with products of incomplete combustion. Photo courtesy of Associated Press, Alexander Fox photographer,

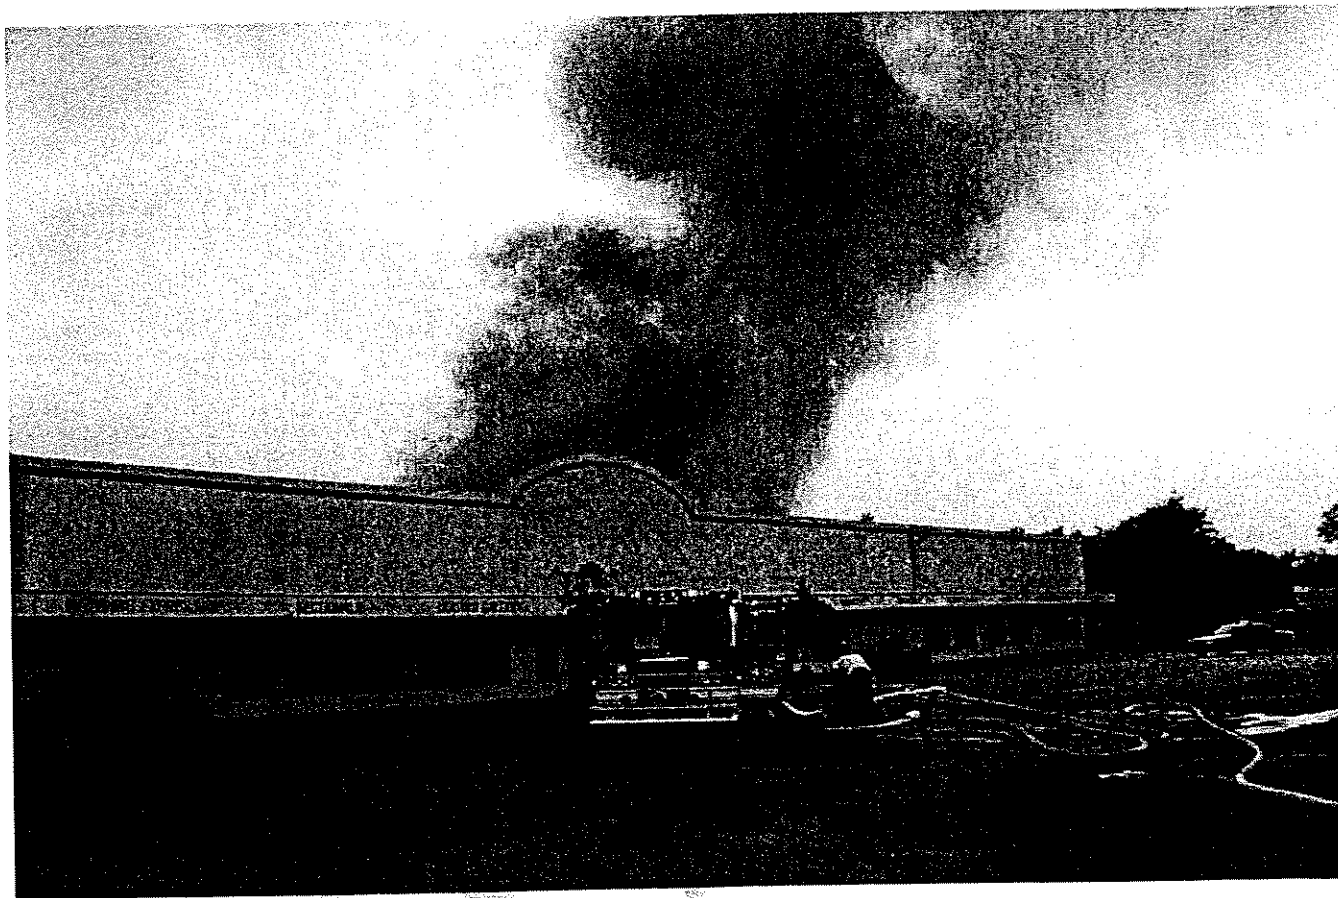
Photo 10: Time approximately 1934 hours. Note almost all on-duty fire fighters dispatched to the scene are inside showroom. Note lack of any fire personnel in front of structure. At this point, the E-11, L-5, E-16, E-15, E-19, and E-6 crews are inside the showroom. Also note how the color of smoke column appears different from previous photo. Photo courtesy of Police Department, Bill Murton, photographer.

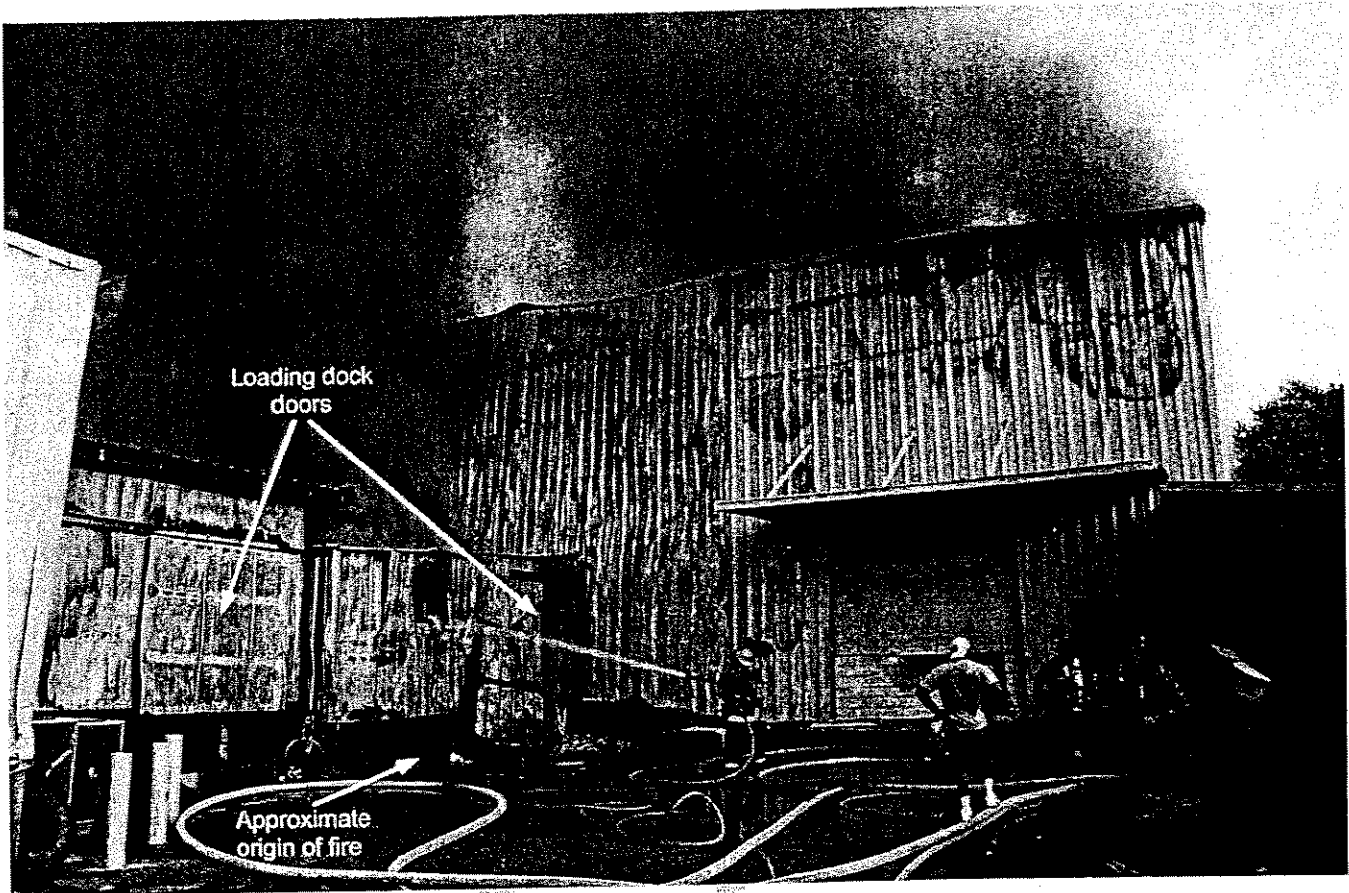
Photo 11: Time is approximately 1934 hours. Loading dock area approximately 20 minutes after first crews arrived on scene. Note heat damage to metal siding on loading dock and warehouse. Photo courtesy of police department. Photo courtesy of Police Department, Bill Murton, photographer.

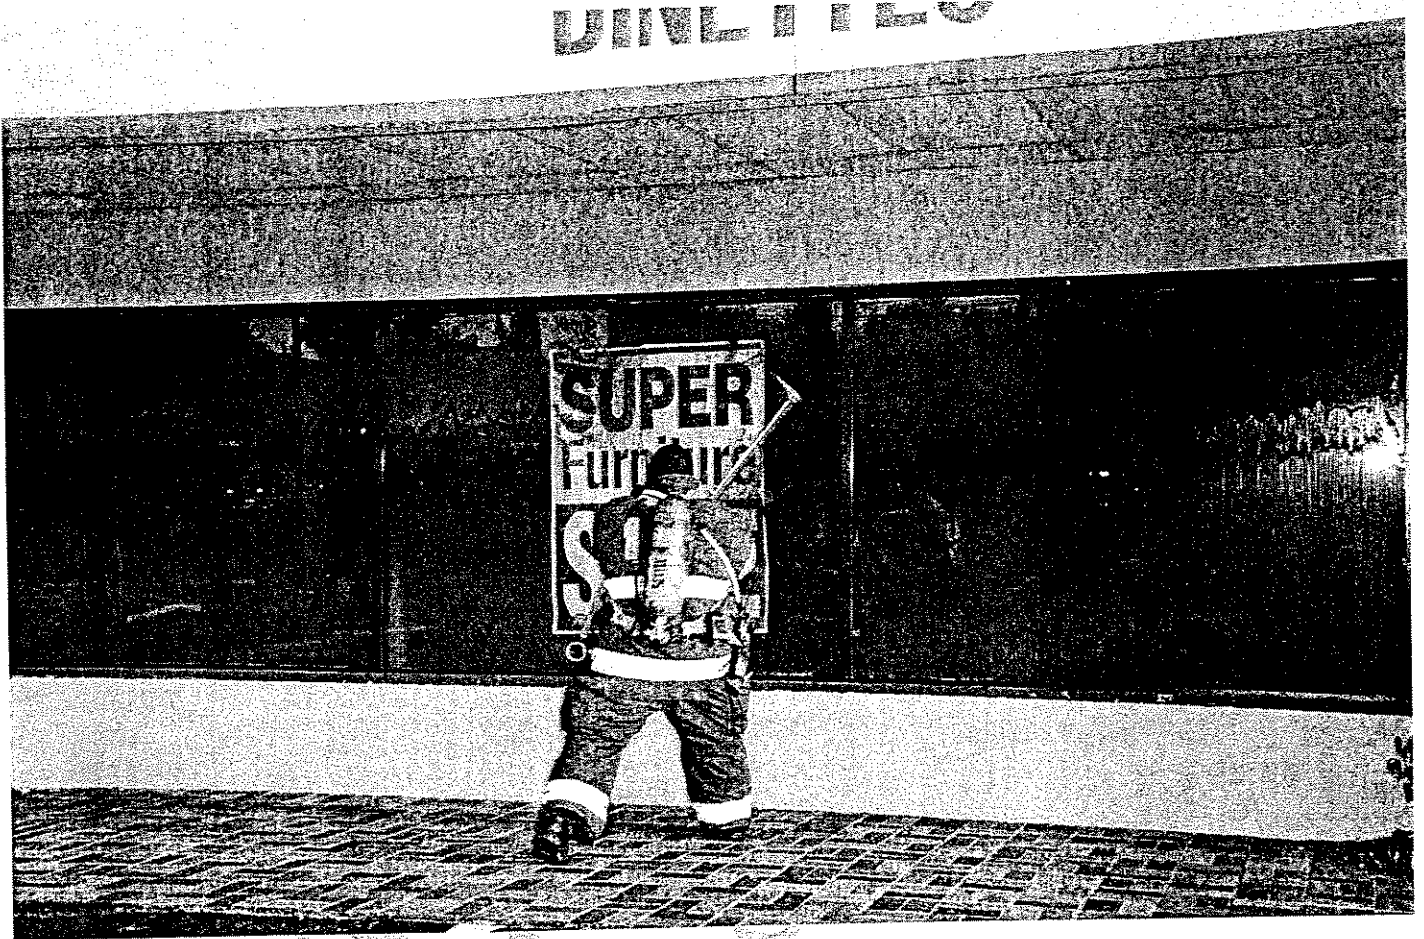
Photo 12: Time approximately 1935 hours. Photo taken just prior to mutual aid department making rescue attempt in front showroom. Note the heavy tar stains on the windows indicating the smoke inside the showroom is rich with flammable products of incomplete combustion. Photo courtesy of Police Department, Bill Murton, photographer.

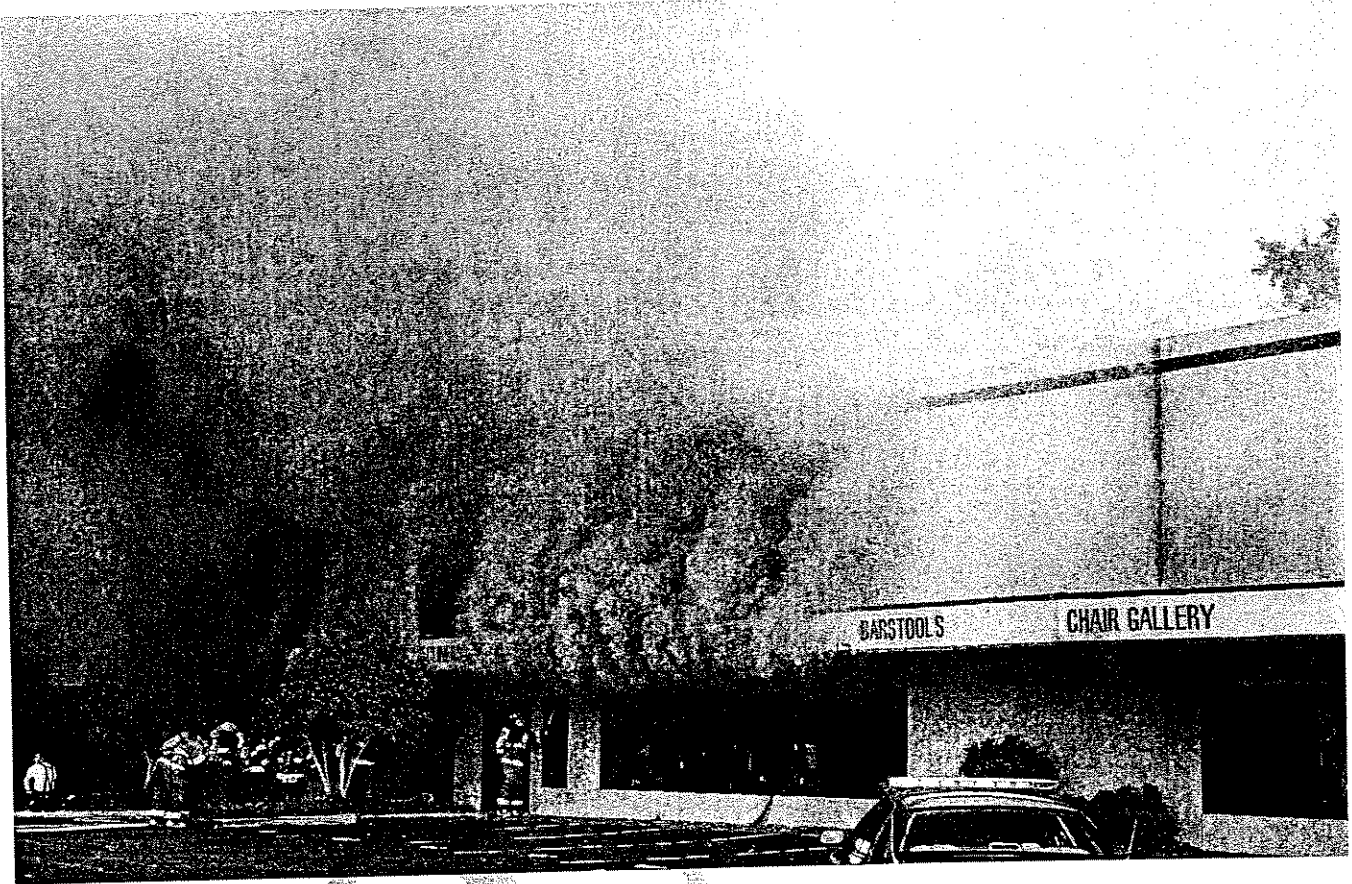
Photo 13: Time approximately 1936 hours. Note turbulent dark gray smoke rolling out of the showroom as the front windows are being knocked out. Mutual aid crew is assembling for search and rescue attempt. Photo courtesy of Associated Press, Alexander Fox, photographer.
