A summary of a NIOSH fire fighter fatality investigation

Nine Career Fire Fighters Die in Rapid Fire Progression at Commercial Furniture Showroom – South Carolina

Fatality Assessment and Control Evaluation Investigation Report # F2007-18

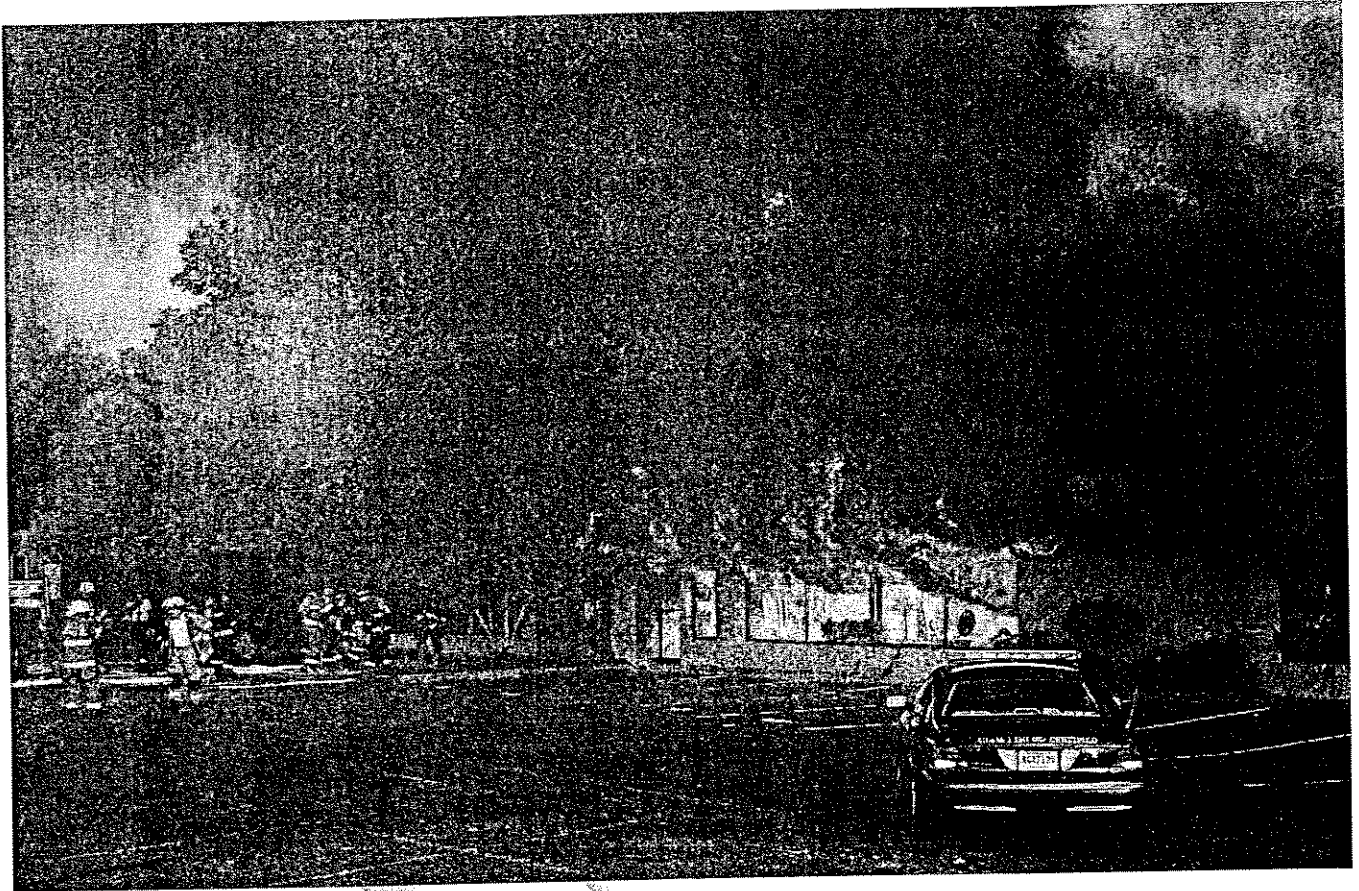
Photo 14: Time approximately 1938 hours. Photo taken less than a minute after mutual aid rescue crew is forced out of the showroom by the interior conditions. Note fire rolling out the showroom windows. Photo courtesy of Bates.

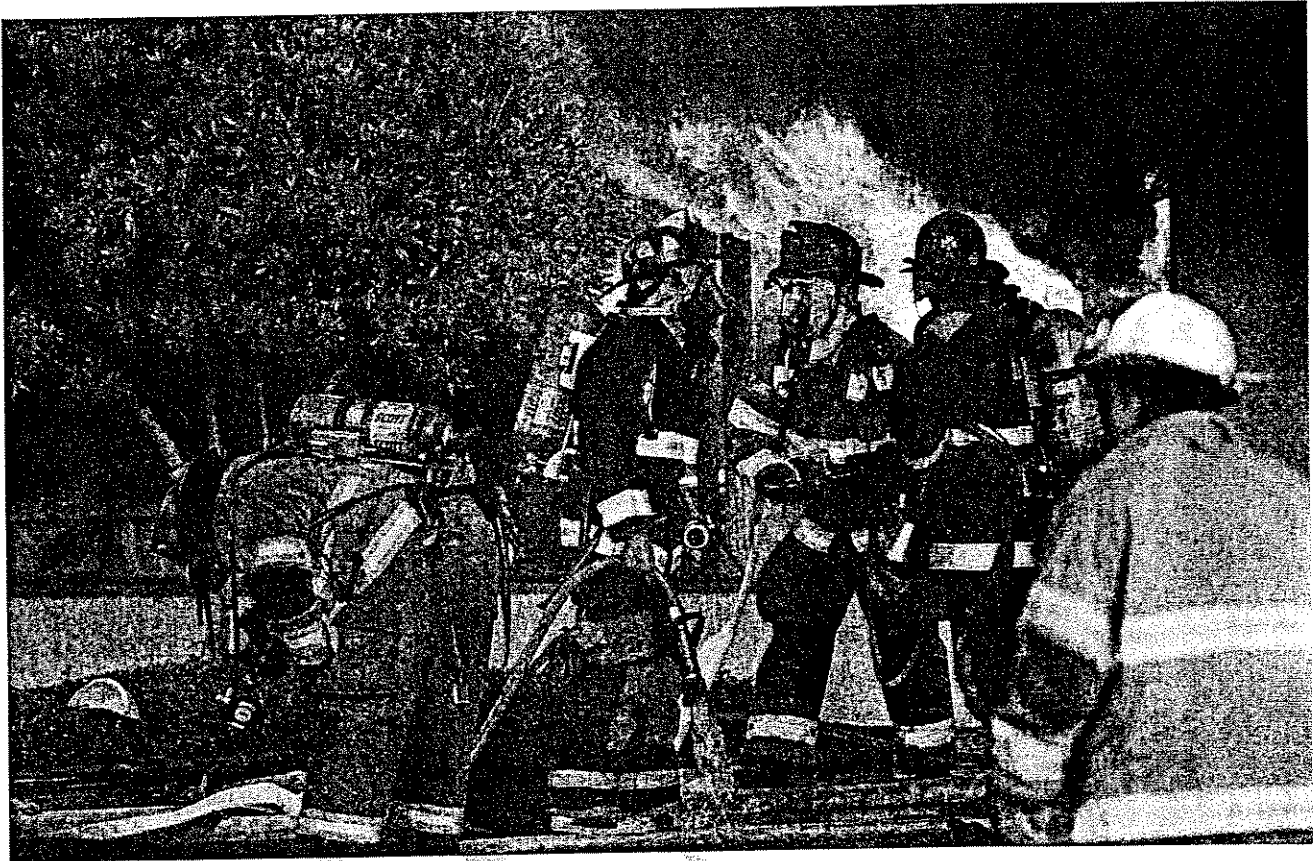
Photo 15: Time approximately 1939 hours. Crews are preparing to make second rescue attempt. Note lack of water pressure on the booster line and the 2 ½" hand line. Also note lack of gloves and hood. Photo courtesy of Bates.

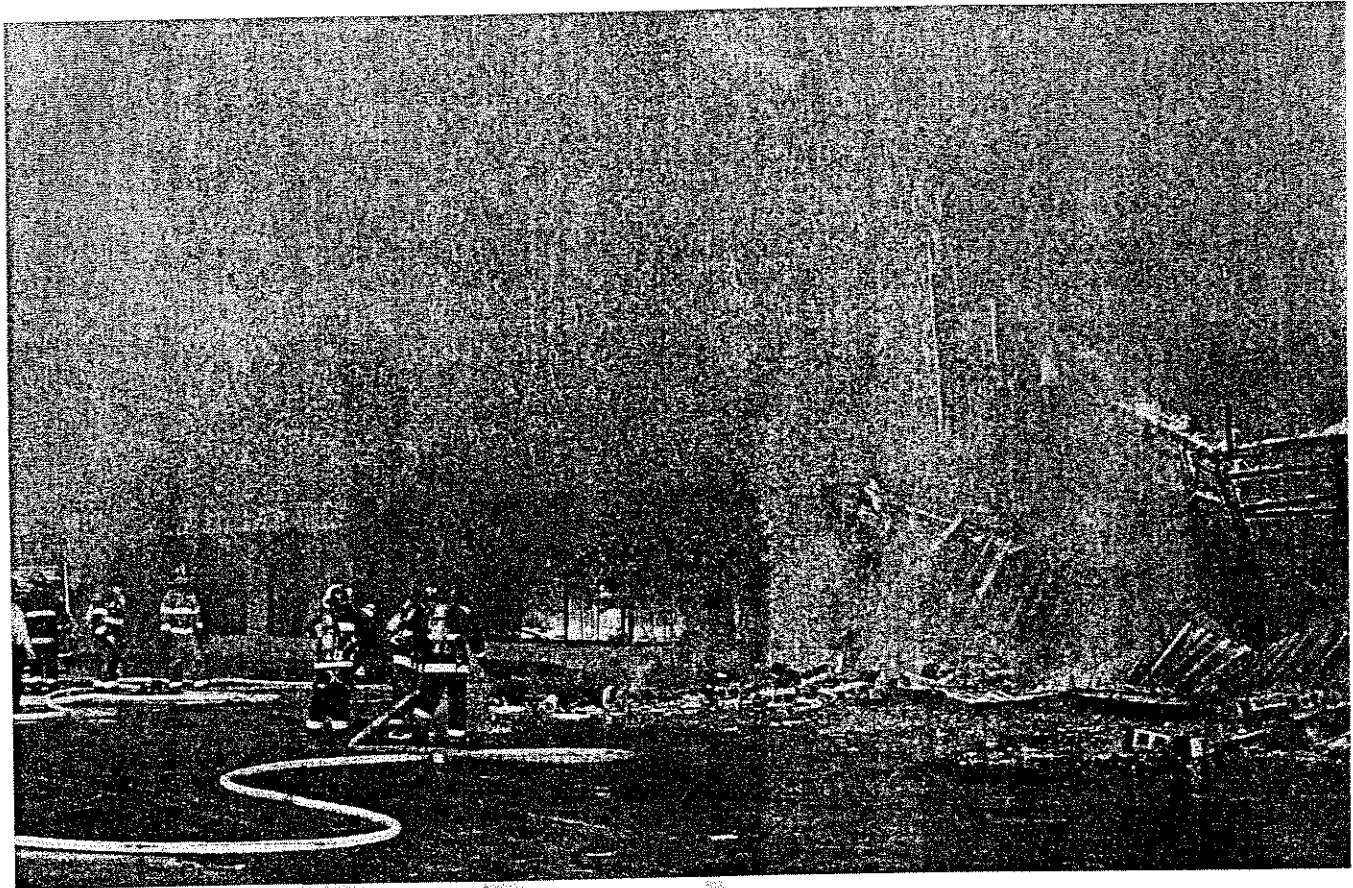
Photo 16: Time approximately 1951 hours. Front façade beginning to collapse as roof over main showroom collapses. Photo courtesy of Bates.
