FIREFIGHTER FATALITY INVESTIGATIVE REPORT

**Sofa Super Store
1807 Savannah Highway
Charleston, South Carolina**

**City of Charleston
Post Incident Assessment and Review Team
Phase II Report**

May 15, 2008

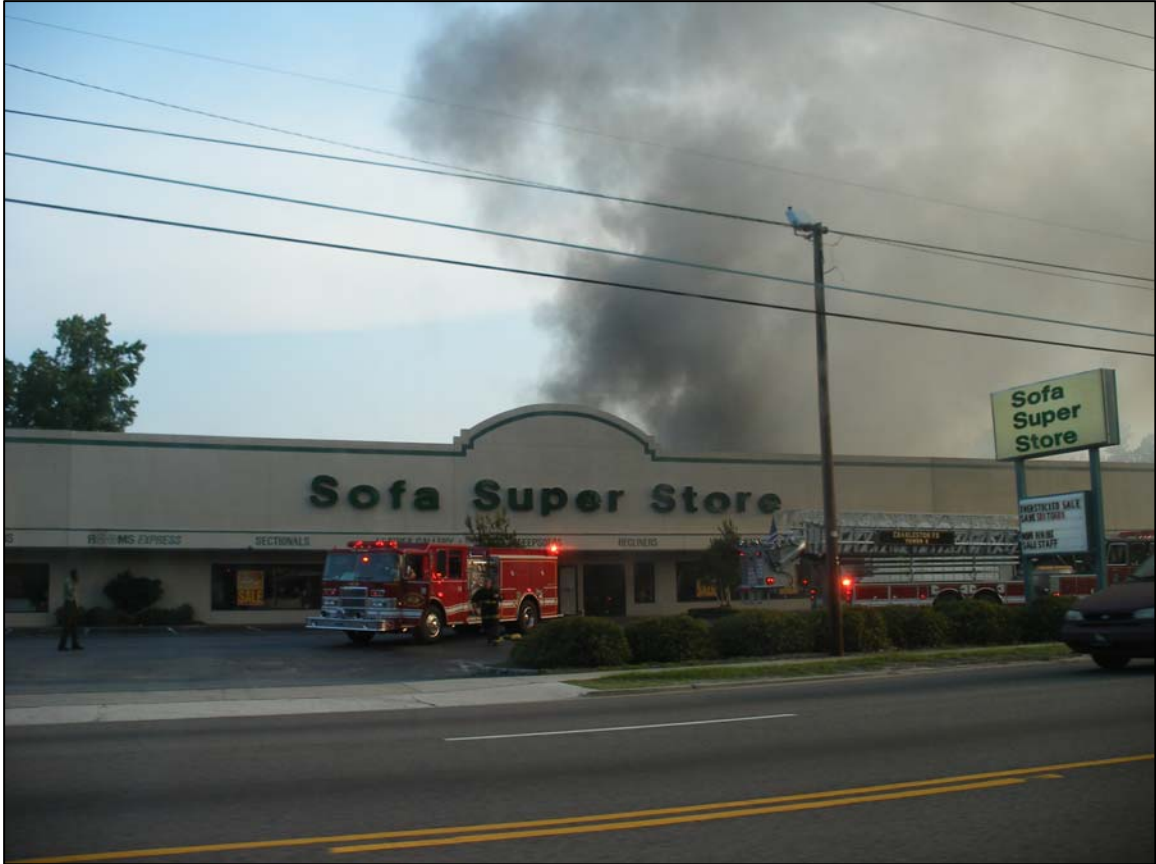
Photo 3: The earliest photo of the front of the Sofa Super Store, taken at approximately 19:16. (Photo courtesy of Lindsay Ackermann)

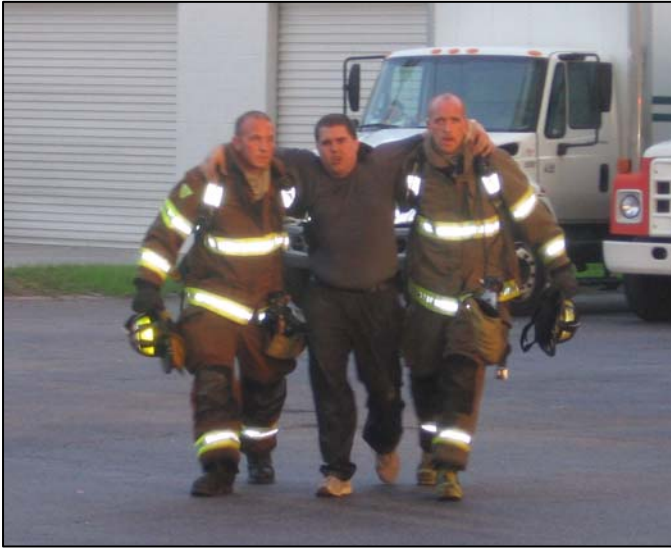
Photo 4: Saint Andrews firefighters escort the rescued civilian to the front of the building at approximately 19:33. (Photo courtesy WCIV)

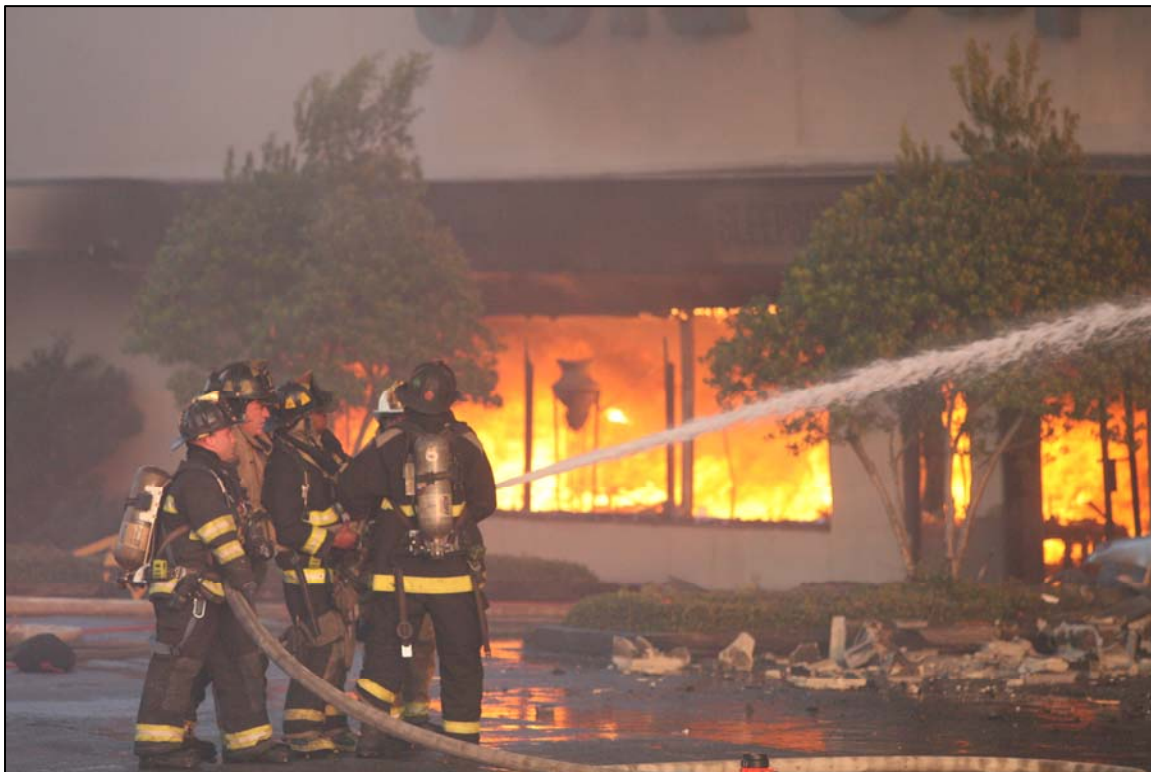
Photo 8: Firefighters flow a 2-1/2 inch handline at the front of the store. (Photo courtesy Charleston Post and Courier)
